Re: Beach management adjacent the Black Point boat ramp

Black Point
Boat Ramp Survey 16/10/2017

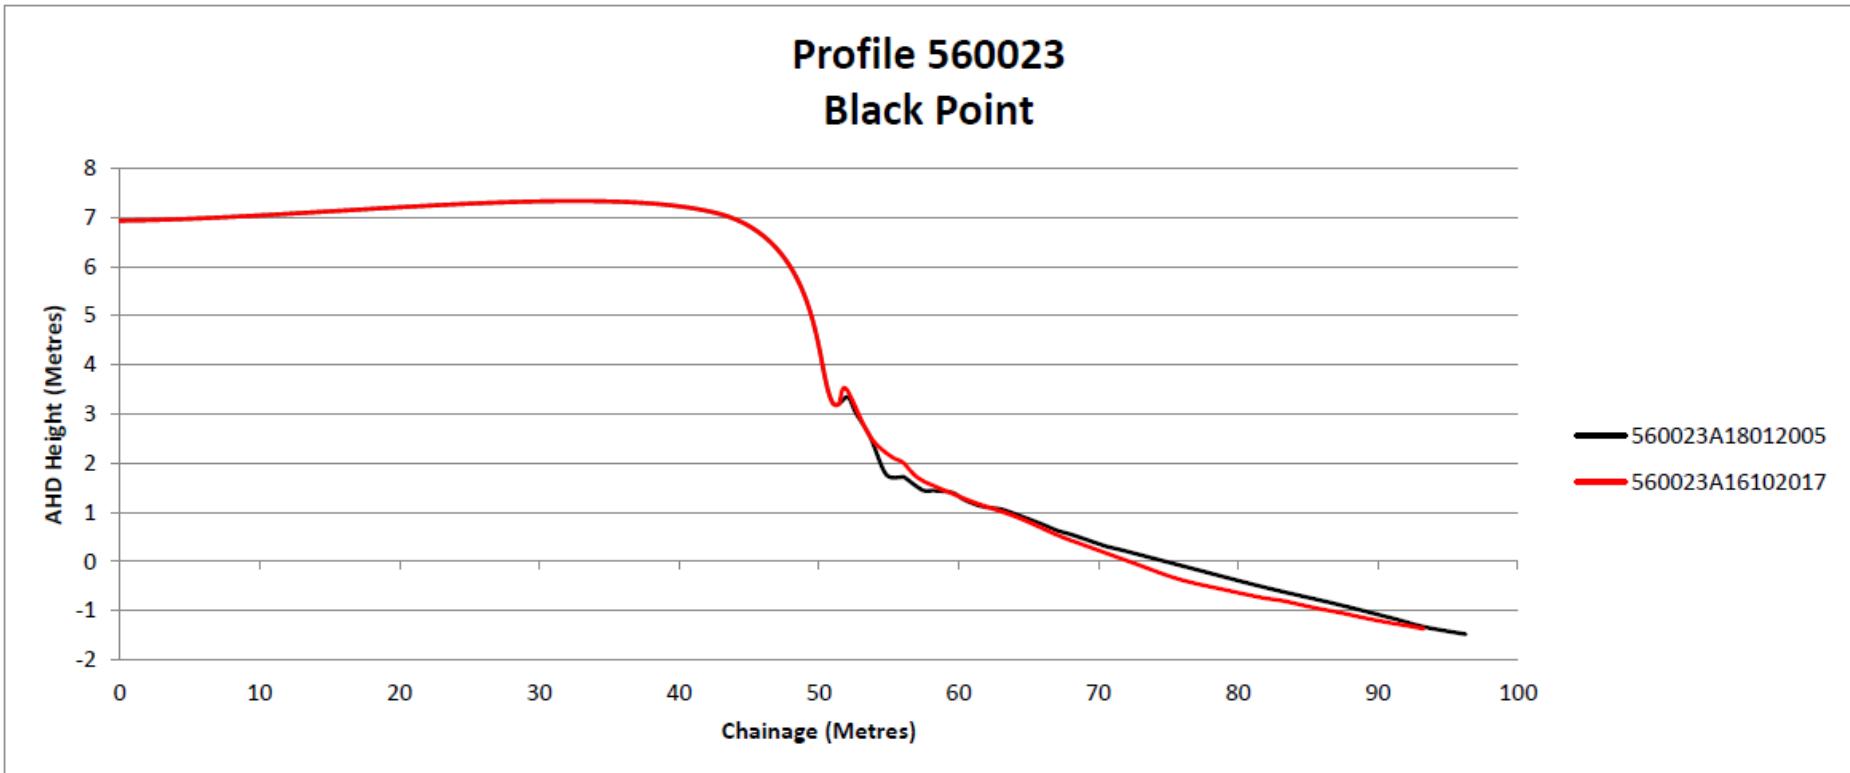
Figure 2: Black Point Profile 560023

The nearest profile to the ramp (560023, 166m south-east of the ramp) was established in 2005 and only resurveyed in 2017. It indicates that there has been a beach volume loss along that profile of 4m^3 , which is a relatively small loss of sand.

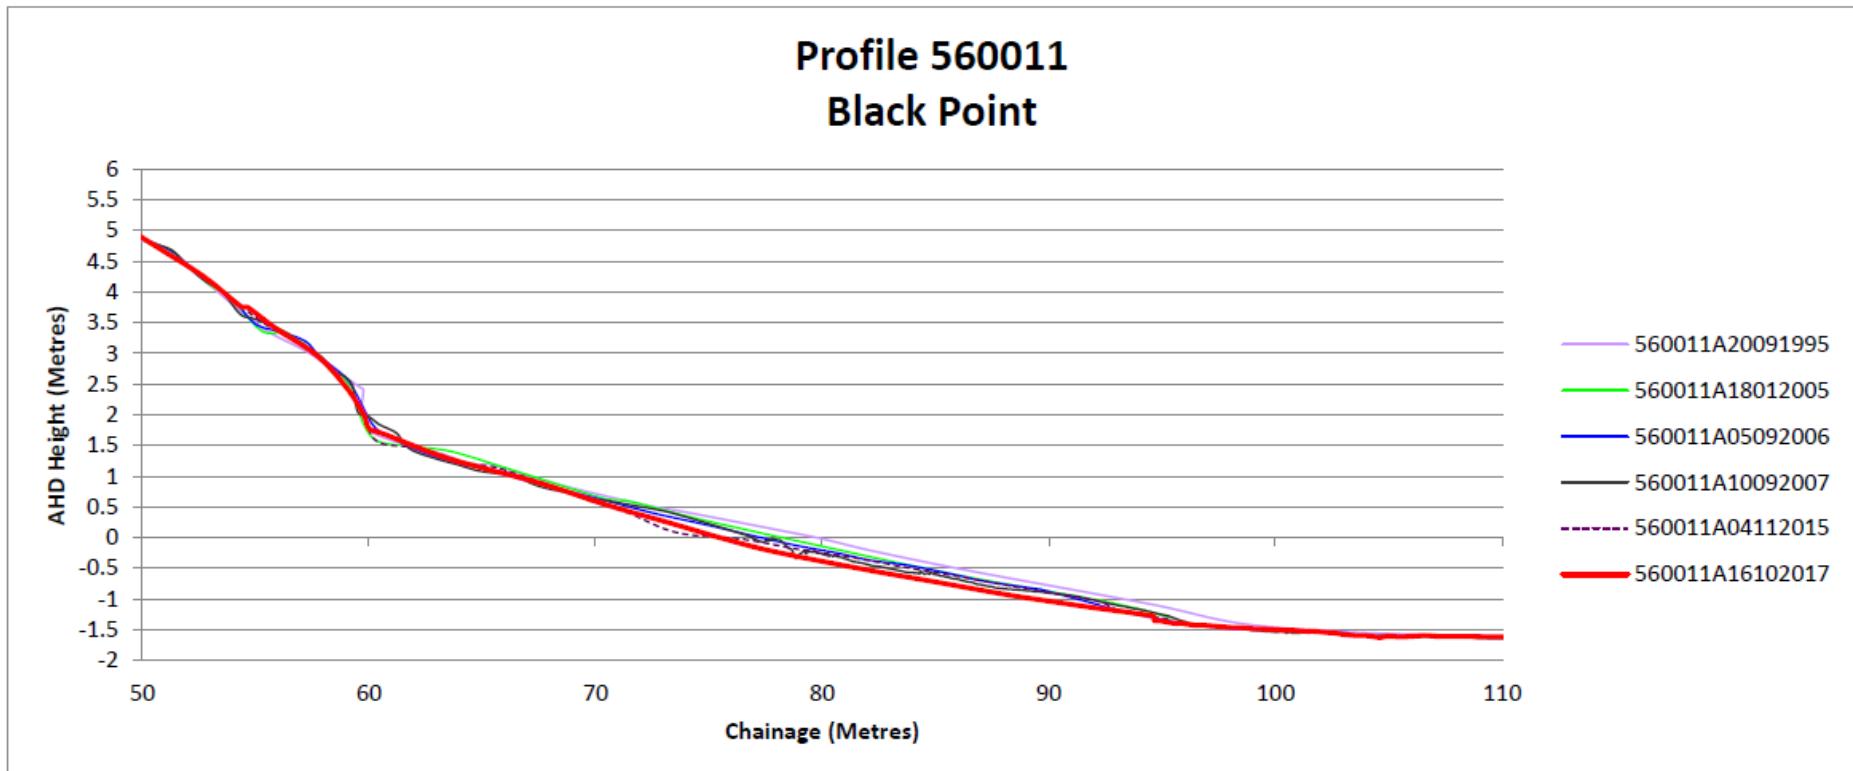
Figure 3: Black Point Profile 560011

The next profile (560011, 250m south-east of the ramp) shows a beach volume loss between 1995 and 2017 of 5m^3 .

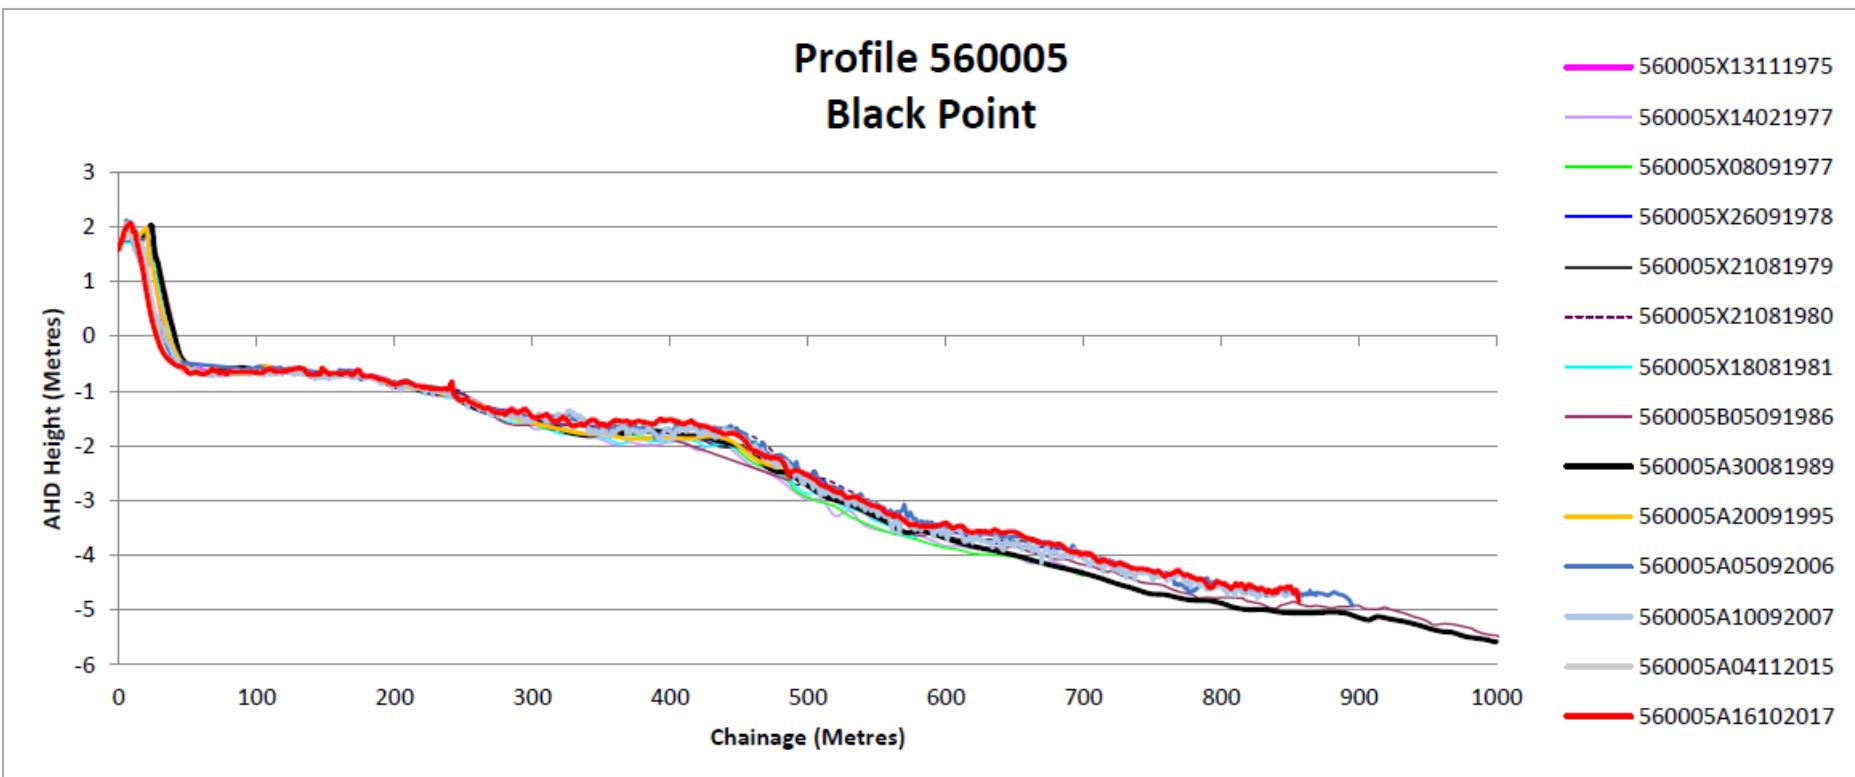
Figure 6: Black Point Profile 560005

The other profiles surveyed appear to be sufficiently far from the ramp as to be unaffected by it. Profile 560005 shows erosion on the dune face but stability over the beach and nearshore area. The others show little trend in beach behaviour.
