**Review of coastal hazards and  
adaptation options for:**

**FOUL BAY,  
YORKE PENINSULA**

**Prepared for:**  
Yorke Peninsula Council

19 May 2023

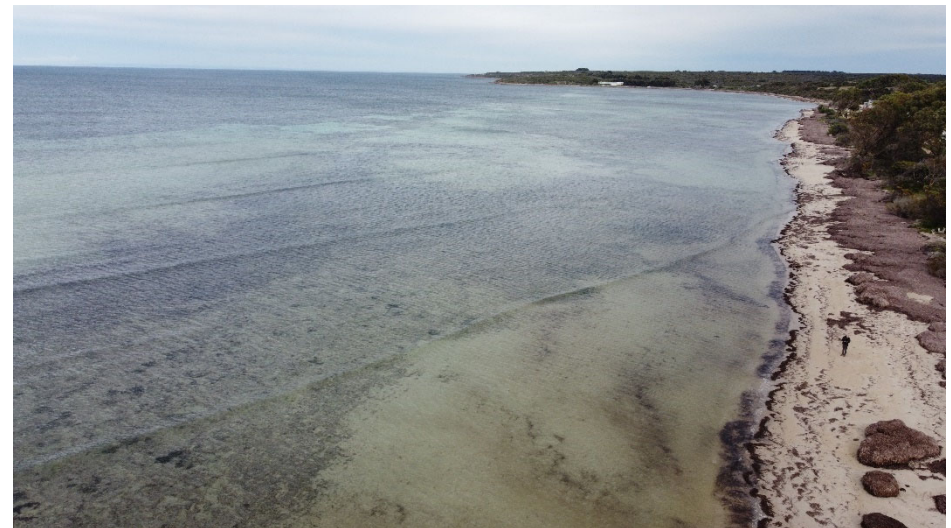
Figure b. Note the oblique way in which the waves (in this photo, very small) interact with the Foul Bay coastline in this location which tend to move sediment eastward (P. Hesp, 2022)

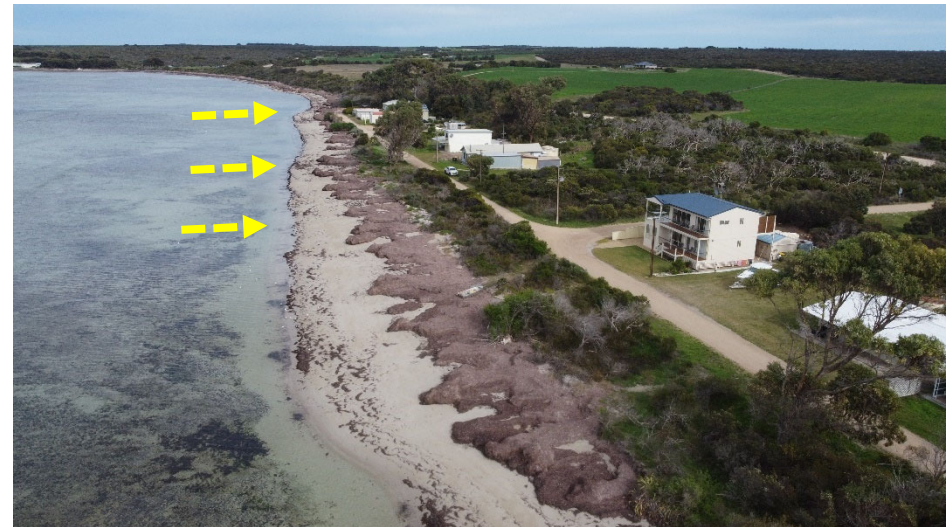
Figure a: The dune system on the western end has been eroded away (P. Hesp, 2022)

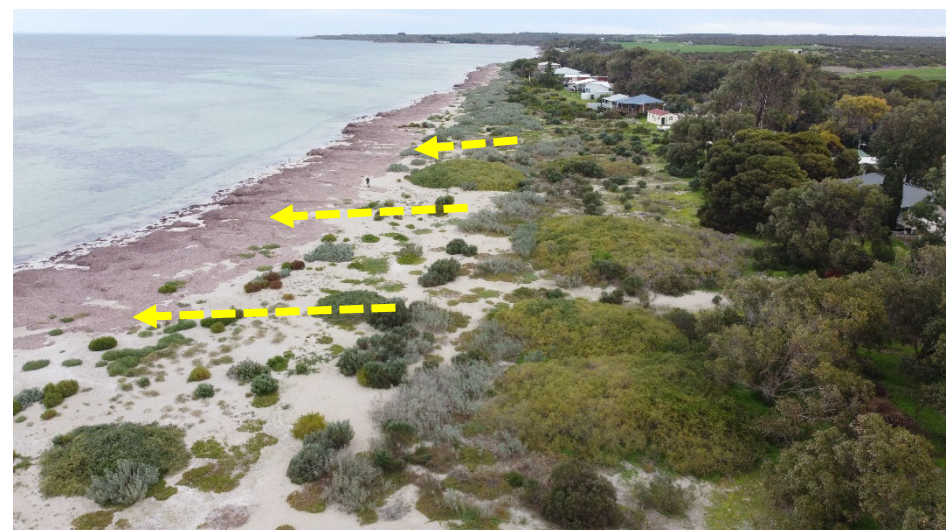
Figure b: The dune system on the eastern end has been prograding (building) (P. Hesp, 2022).

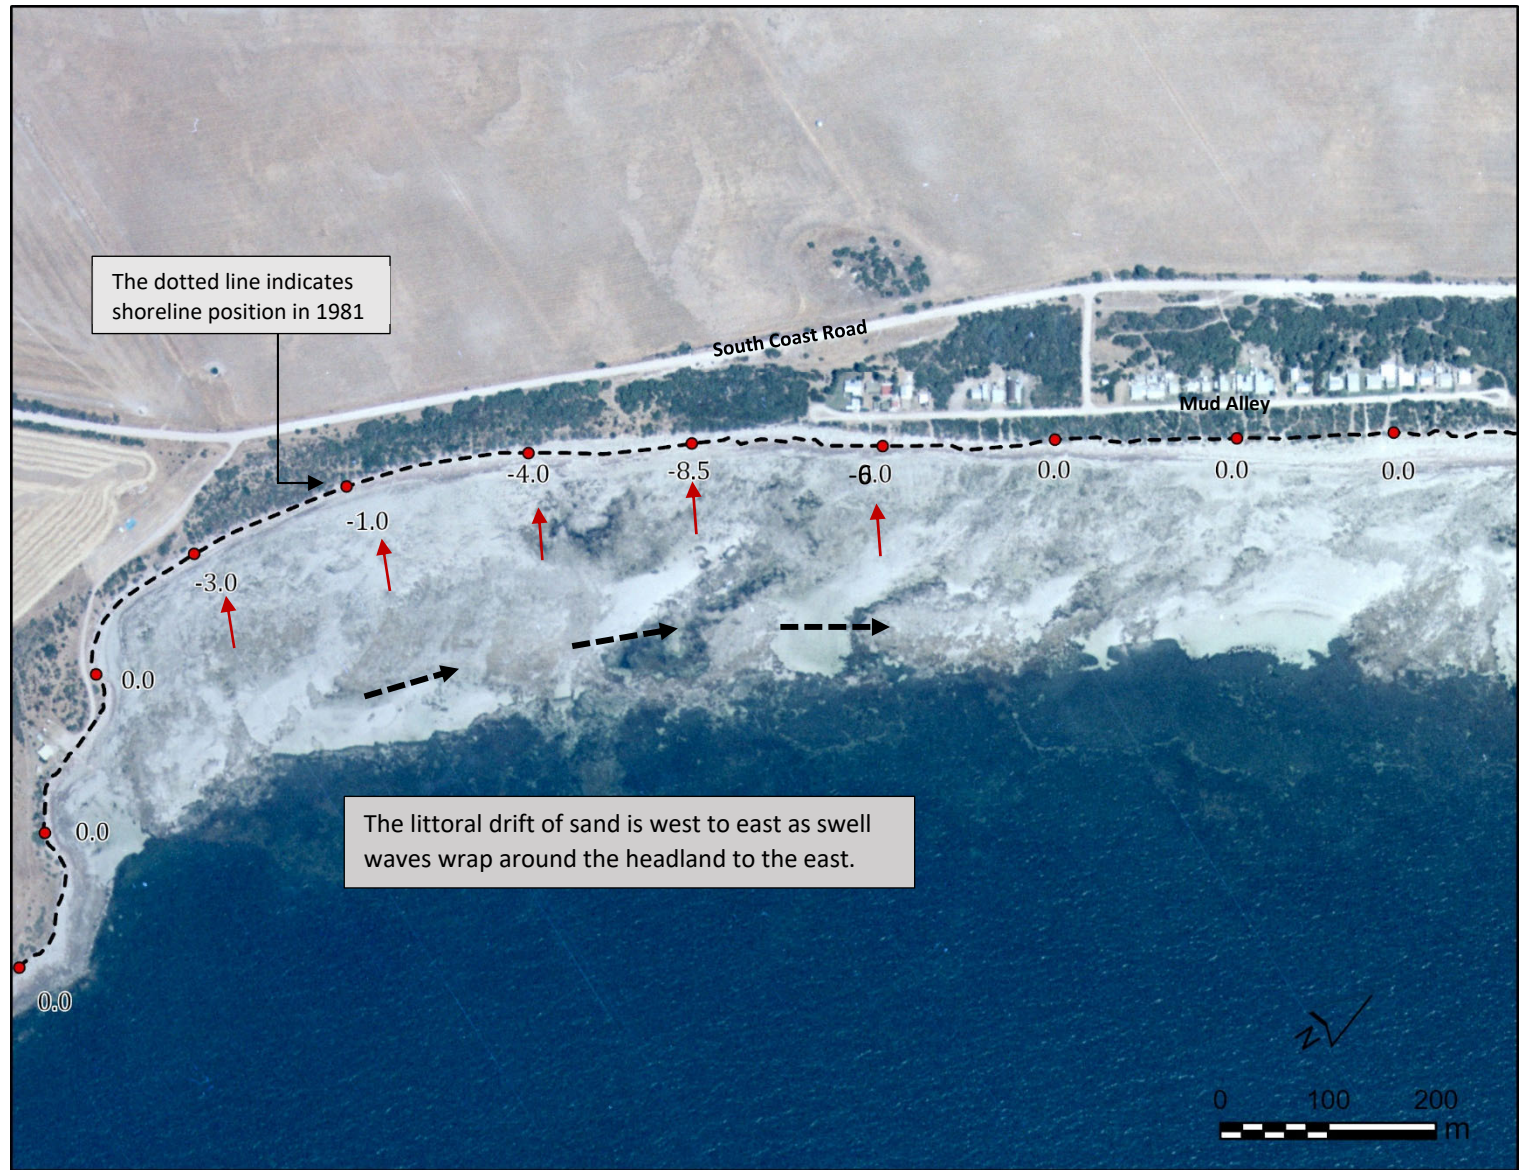
The erosion from 1981 to 1992 (ten years) occurred on the western end of Foul Bay at net change of ~-3m to -8m.

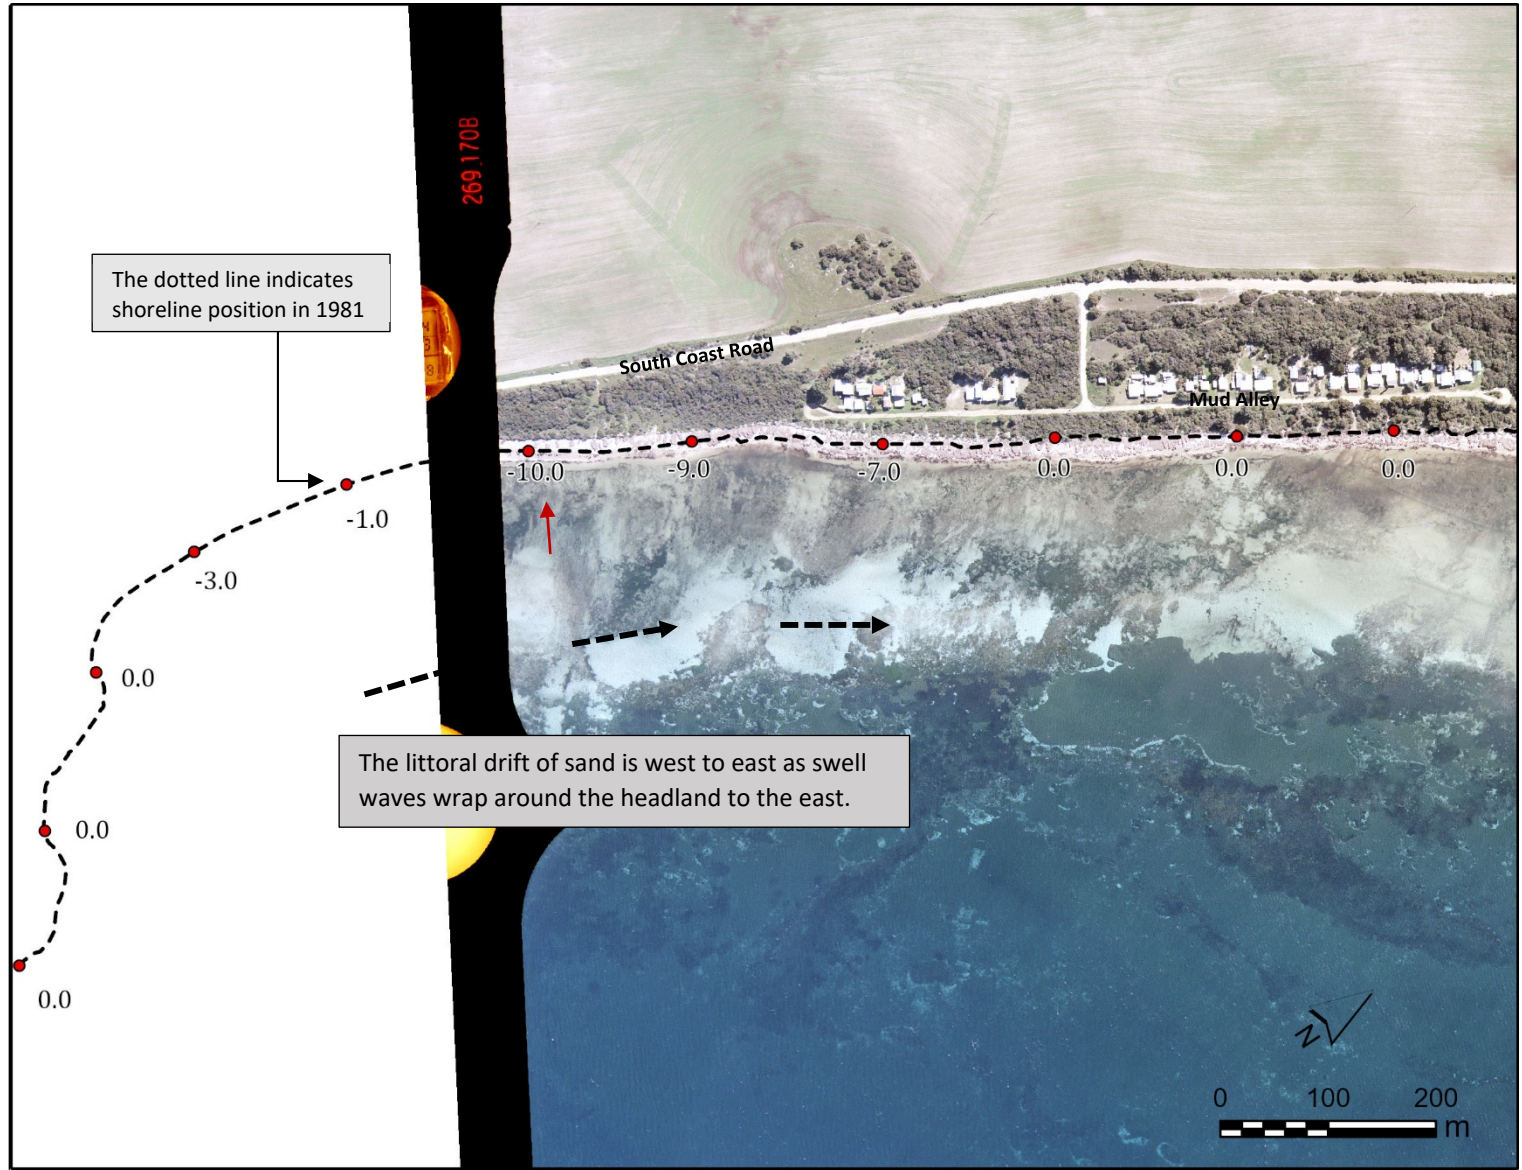
The erosion from 1992 to 2001 (~ 10 years) appears to have stabilized nearer to Mud Alley but increased towards the boat ramp. However, the interpretation is limited by the truncated photograph.
