COASTAL EROSION ASSESSMENT

BEACH ACCESS ROAD

BALGOWAN

Project No: 16533

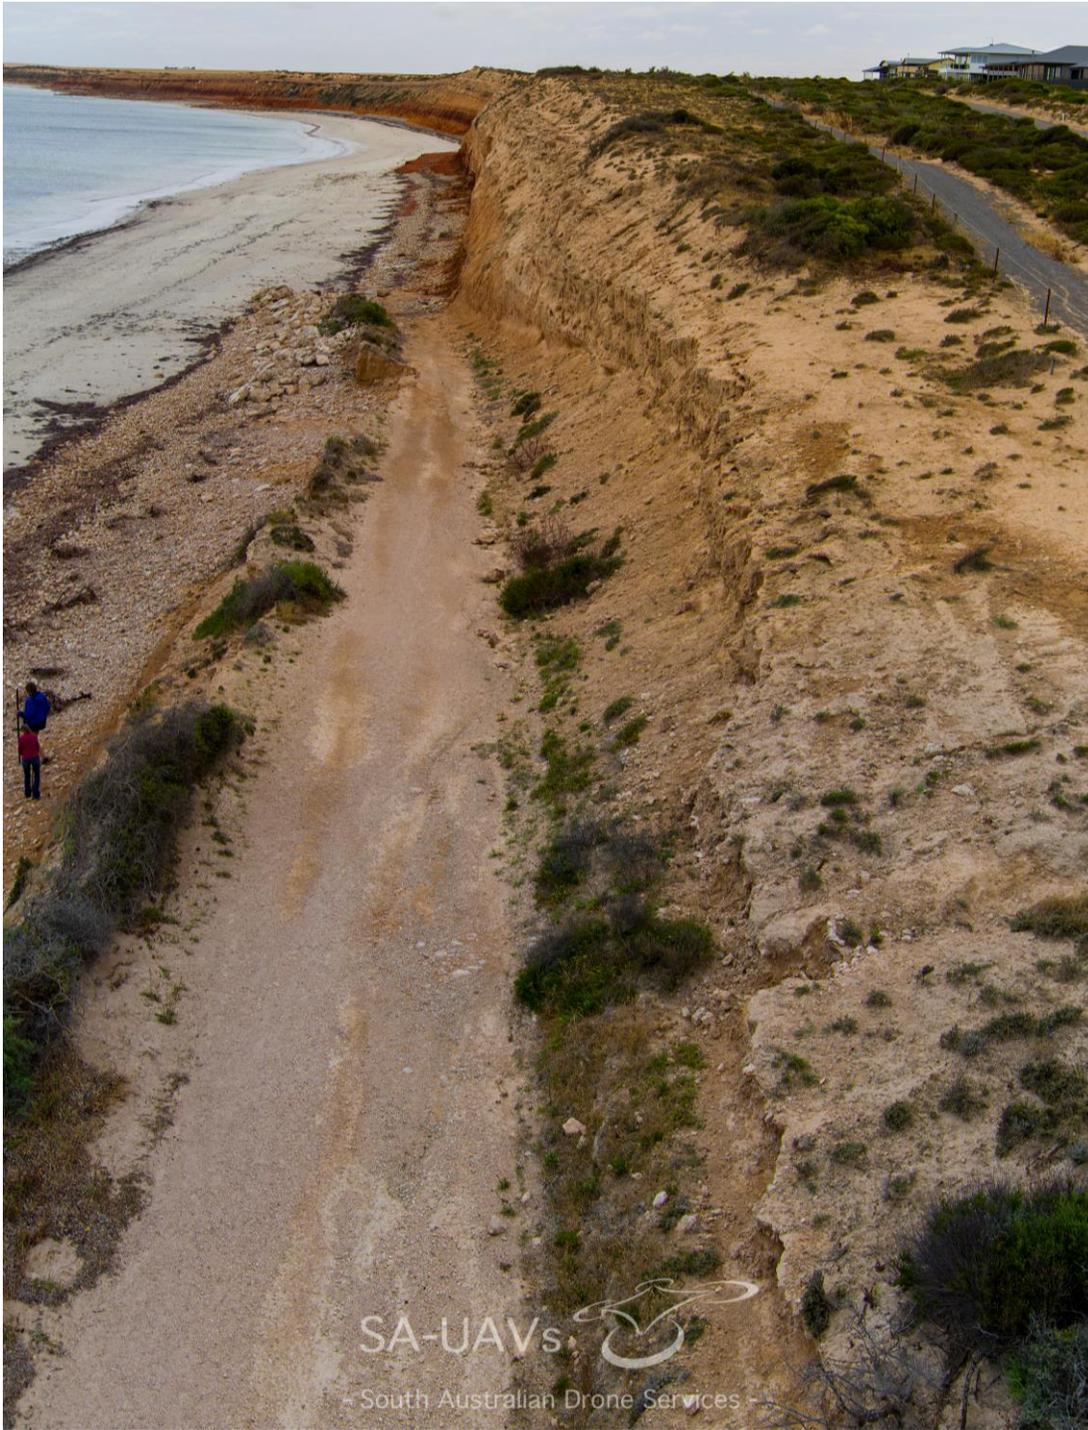
Figure 1- Existing cliff is unstable east of the road.

The cliff face east of the access road is generally uncompacted sand, collapsing in the lower half. The top of the cliff is unvegetated in some sections (refer figure 1). The cliff face is near vertical in the middle. It is critical that these sections are protected from further erosion of the cliff.

2. Stabilize the cliff face (in areas as shown in dwg. 16533-2-4) as follows:
 - Batter the top of the cliff and add new compacted fill where required, to achieve a cliff slope of 1:1.5 or flatter.
 - Add top soil to devegetated areas and over new fill.
 - seed the areas which have been top soiled and/or devoid of vegetation.
 - Install a double thickness layer of Geofabrics Jute Mesh over the areas of slope which have had top soil added and/or are devoid of vegetation. Install Jute Mesh with propriety galvanised metal pins 30mm x 300mm x 4mm Ø, at the rate of 5 pins/m² ensuring that all laps of Jute are fully pinned
 - Water to promote germination and plant growth. Tend to plants as required.

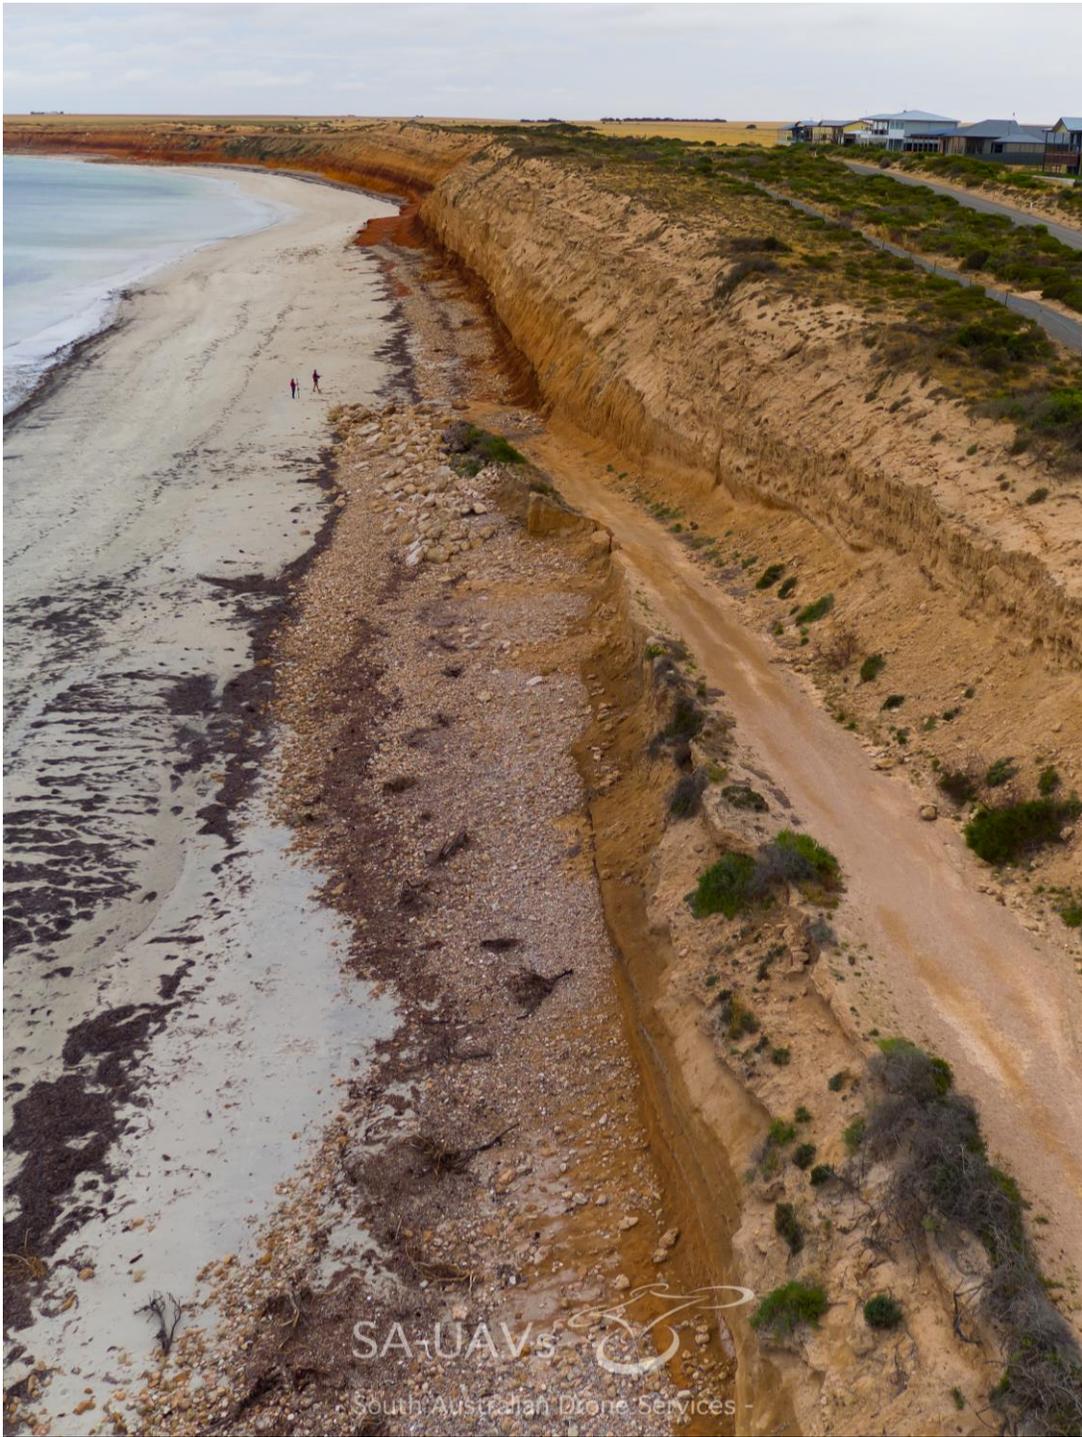
Figure 2- Existing cliff west of the road is unstable. It is collapsed and undercut in some sections.

The cliff face west of the access road is generally uncompacted sand. The sand is mostly unvegetated and is loose and collapsing. The cliff face is generally steeper than 1:1.5 slope.

The erosion on the cliff face west of the access road is of two different types. The erosion below approximately 4m AHD is from wave action. This can be seen in the collapsed and undercut road.

1. Edge the base of the cliff in rock protection up to 4.4m AHD to prevent wave erosion. This is undertaken by:
 - Remove and dispose of existing erosion protection (rocks) at base of cliff, as required.
 - Excavate to hard clay or bedrock, to found toe of rock wall.
 - Batter the slope to grade 1:1.5.
 - Installation of geofabric to prevent washout of sand under/behind the wall
 - Installation of smaller secondary armour rock
 - Installation of larger primary armour rock to resist wave attack.

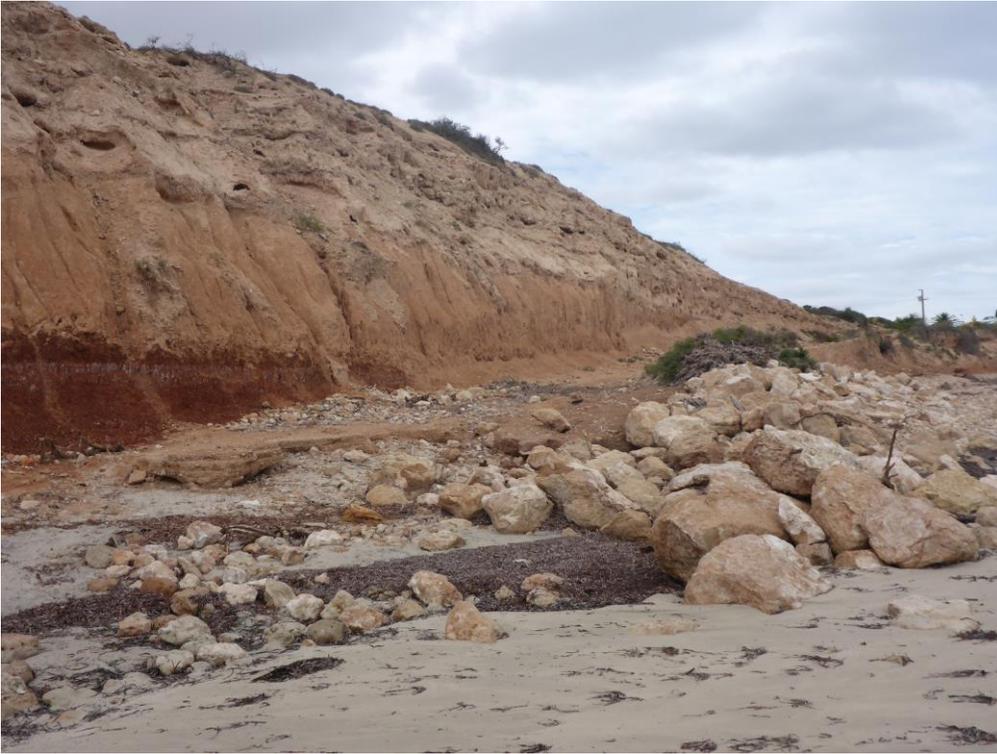
Figure 3- View of the bottom of the existing access ramp. Some sand and rock protection has washed away.

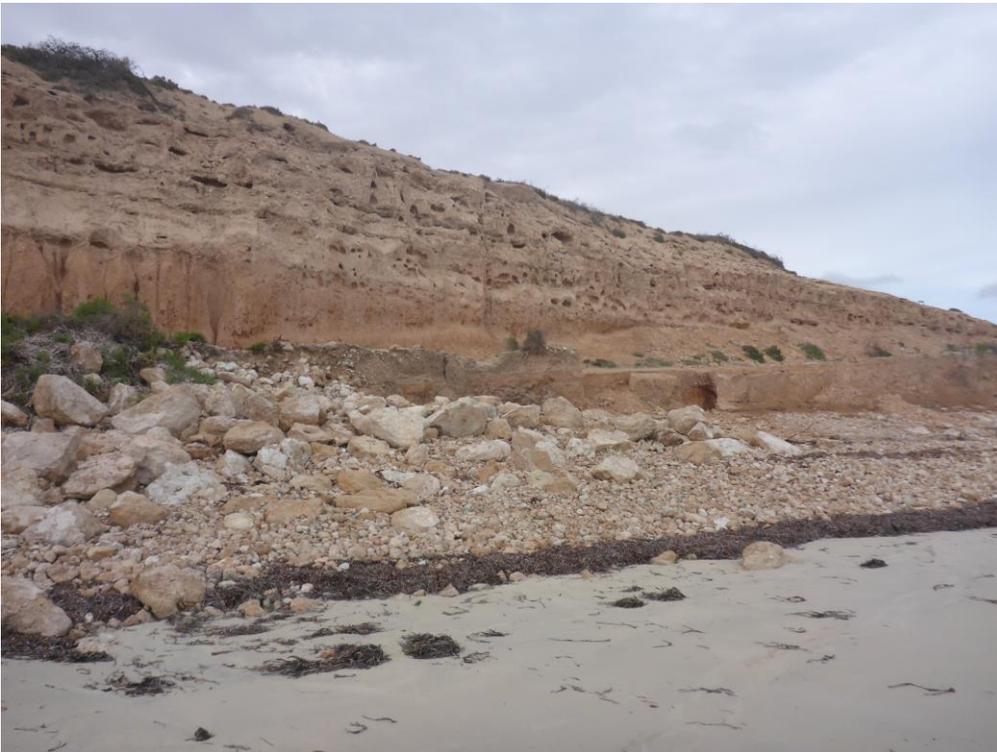
Figure 4- View of the bottom of the existing access ramp.

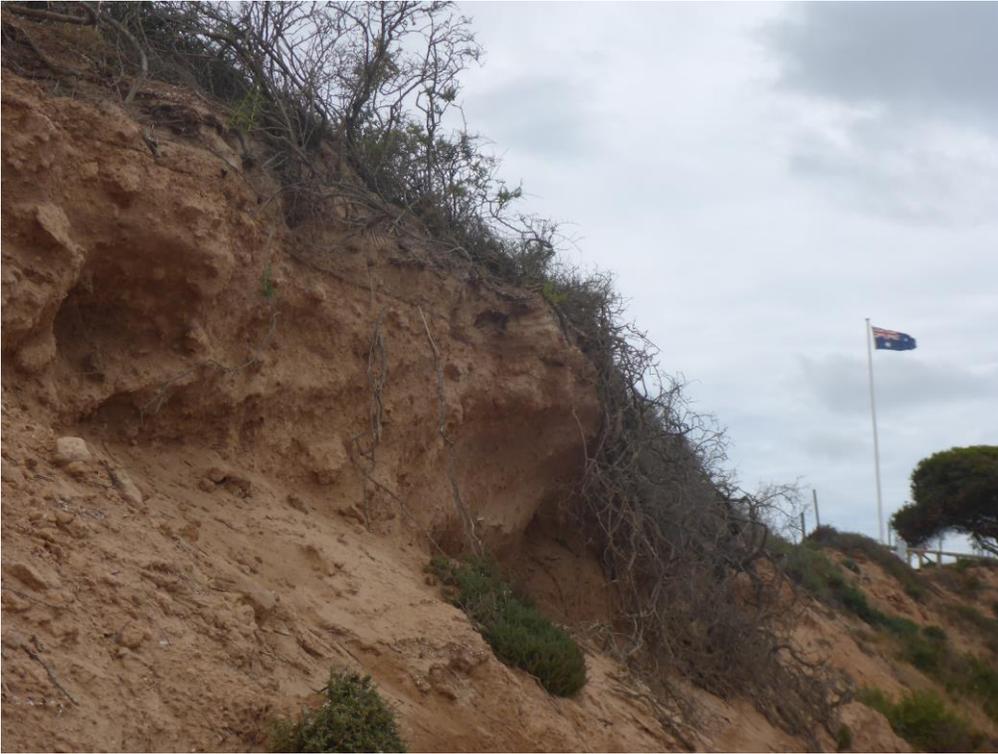
Figure 5- Undercut sections of cliff west of access ramp.

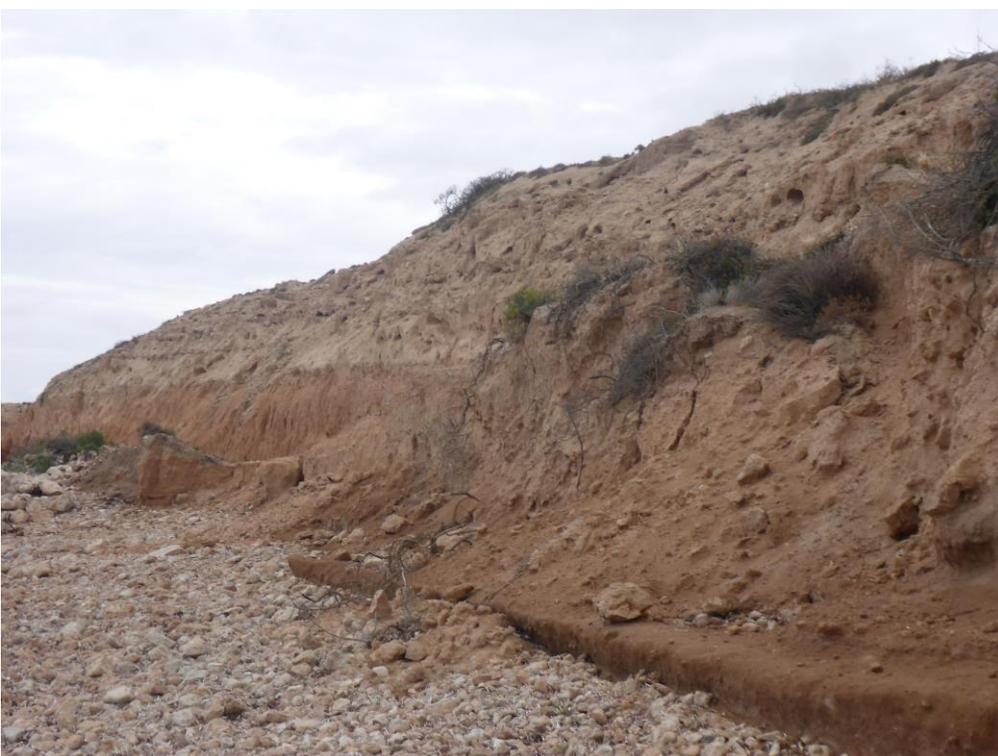
Figure 6- Severely eroded cliff west of access ramp, loose collapsing sand.

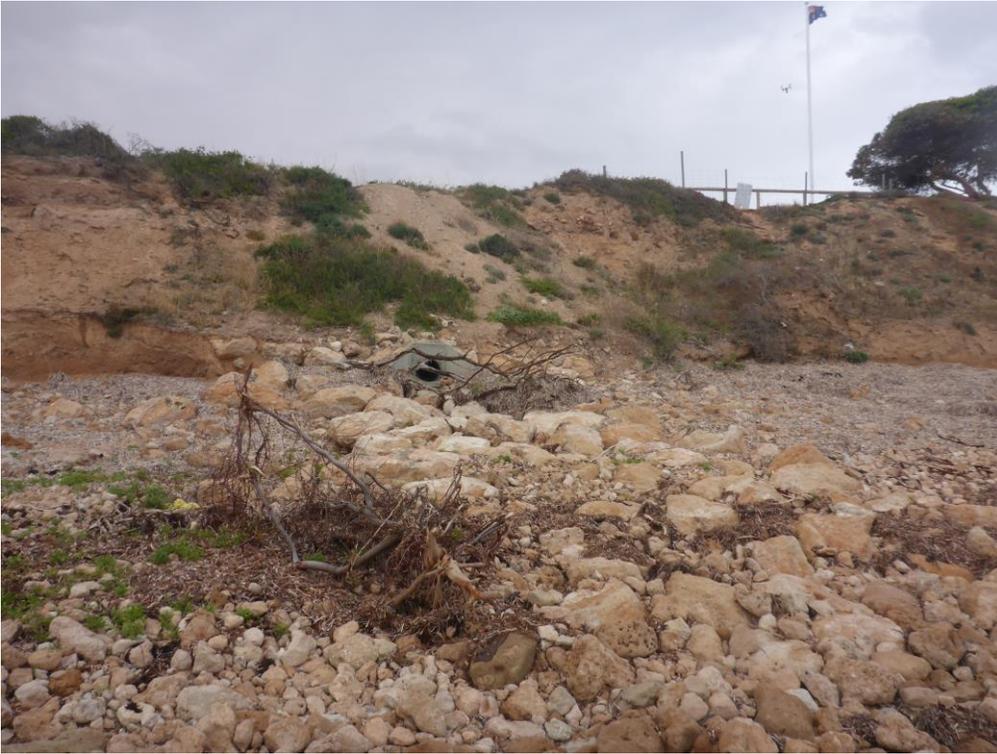
Figure 7- Existing stormwater outlet and rock protection at base of cliff, southern end of access road.

Cliff erosion can often be exacerbated by inadequate stormwater management over the top edge of the cliff. The effectiveness of the existing stormwater outlet that discharges stormwater from the carpark over is unknown.
