# Yorke Peninsula Council

## Marion Bay Boat Launching Facility

### Options Review Report

June 2017

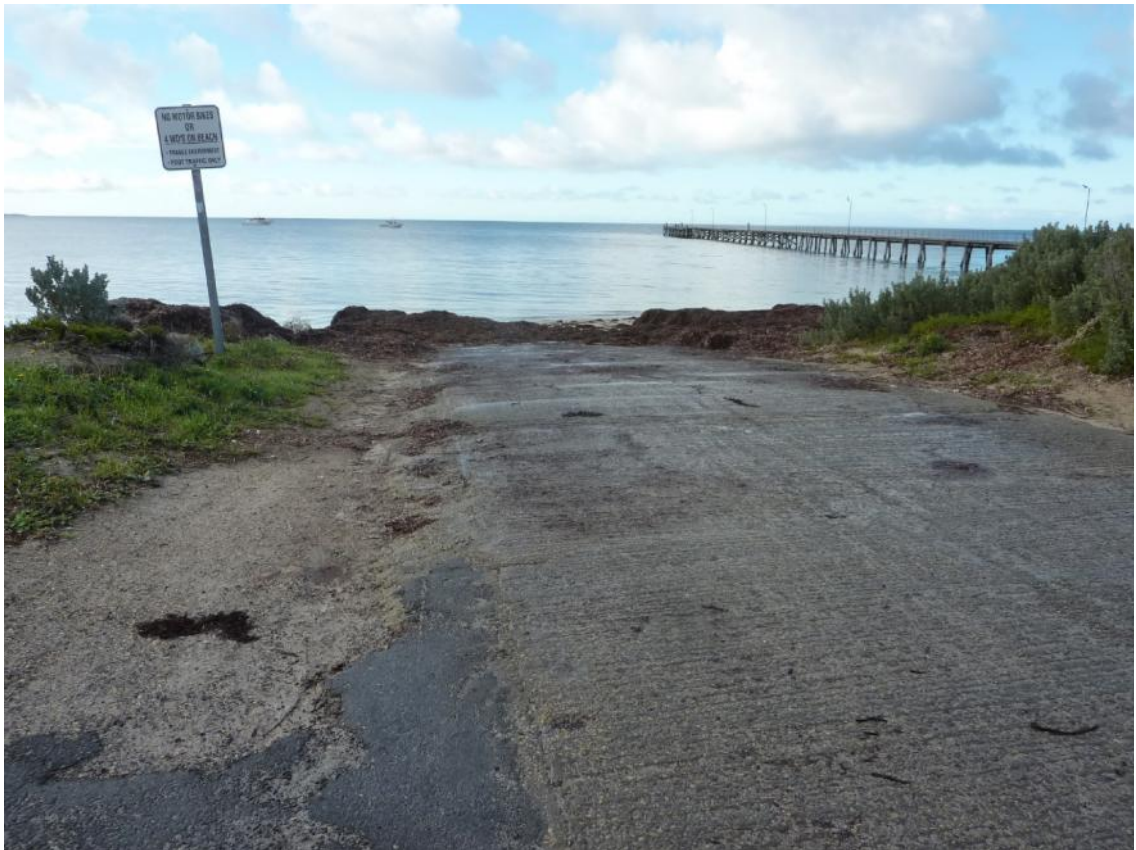
Figure 2: Marion Bay Boat Ramp (June 2016)

The current facility consists of a single lane, low gradient, concrete ramp accessed via a sealed roadway to the ramp, and a car/trailer parking area. According to stakeholders, a boat ramp has been in this location for approximately 50 years.

- Wave Heights – these need to be reduced at the boat ramp
- Ramp Condition – the current status creates potential safety problems in both launching and retrieval due to a deep drop-off at the end, non-compliant gradient, and its orientation to the prevailing wave conditions.

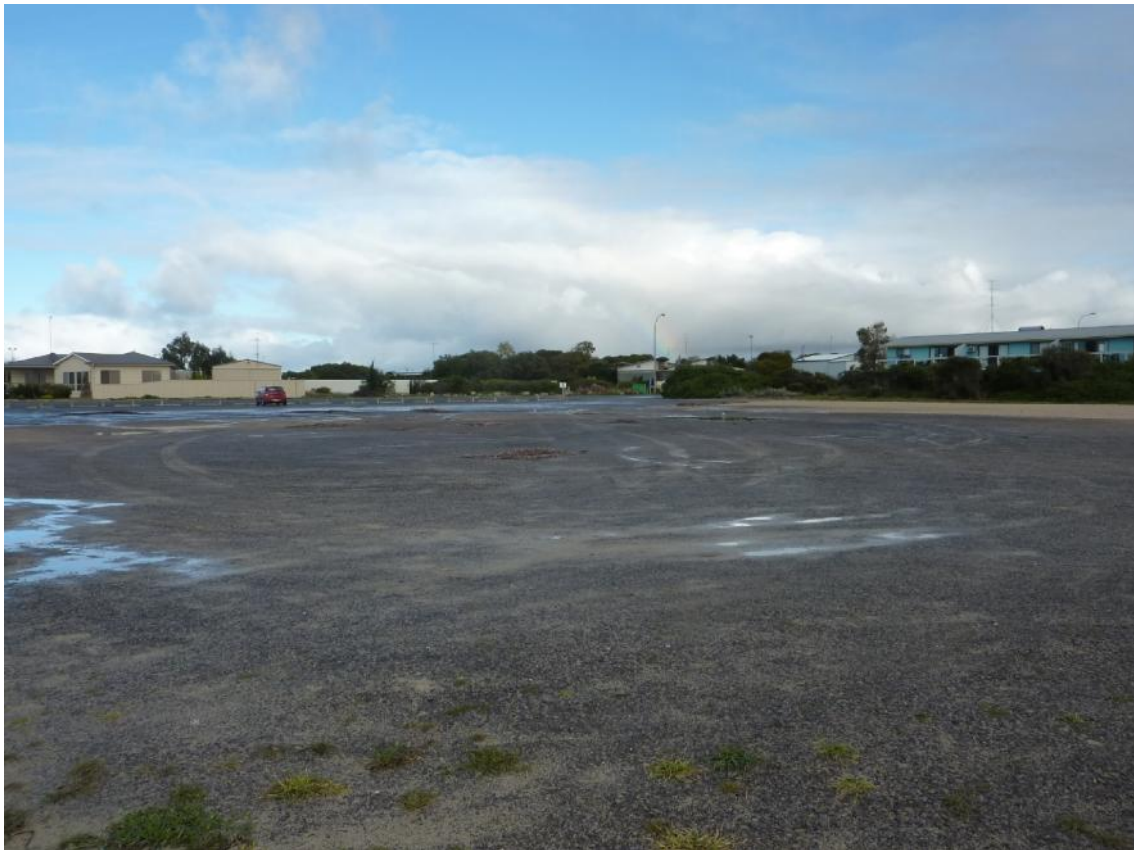
Figure 3: Marion Bay Boat Ramp Car Park (June 2016)

The car park is currently at a level of 2.0 – 2.5 m AHD. This level is currently sufficient for most of the weather conditions encountered, however the car park is still subject to occasional inundation during storm events where large waves coincide with high tides or localised storm surge. The survey data is included on the options sketches in Appendix B.

As discussed in Section 3.2, the car park level is occasionally inundated. However, as sea levels rise it is anticipated that the car park will be inundated more frequently.

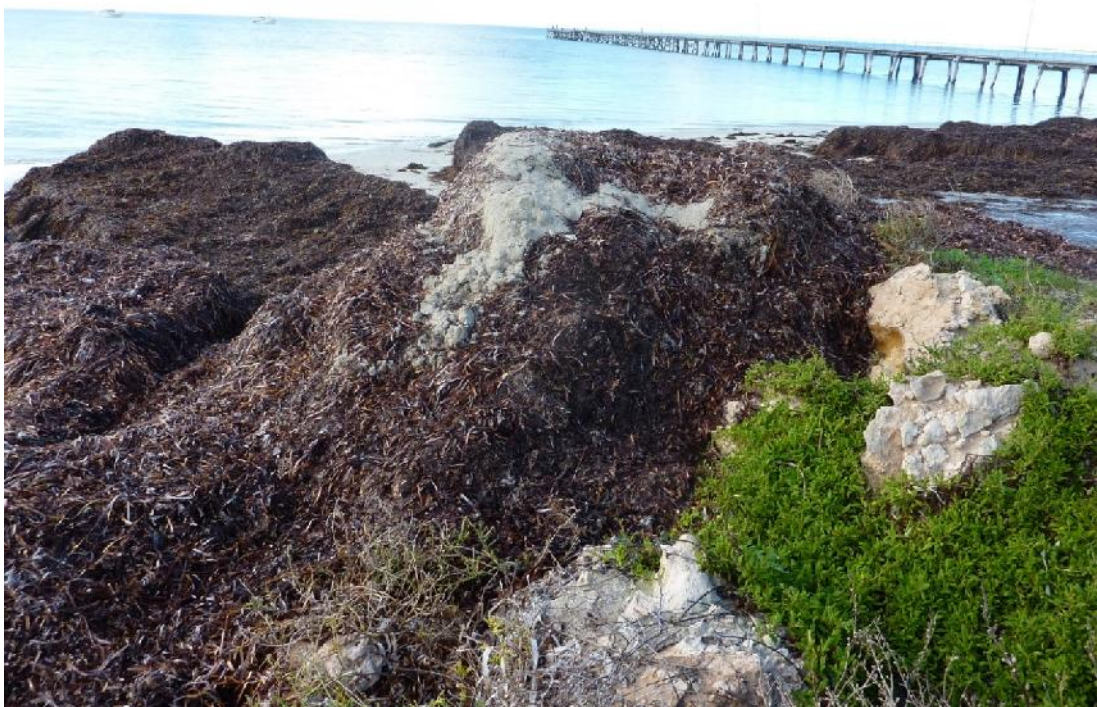
Figure 10: Seaweed Wrack on and around Marion Bay Boat Ramp

Waves wash seaweed wrack onto the beach area where it accumulates on the boat ramp. Under elevated water level and wave conditions, the wrack is sometimes carried up into the adjoining car park. There is currently no individual entity that takes responsibility for removing the seaweed wrack; accordingly, wrack is removed by locals on an as-needs basis.

The introduction of an upgraded boat ramp structure to provide a Category 2 rating (or above) has a high likelihood of creating an impact on the existing local coastal processes. As with the seaweed wrack, sand depositions are likely to increase adjacent to the structure, resulting in increased maintenance requirements.
