Former Edithburgh Waste Depot

Landfill Gas Risk Assessment

Access Planning

June 2014

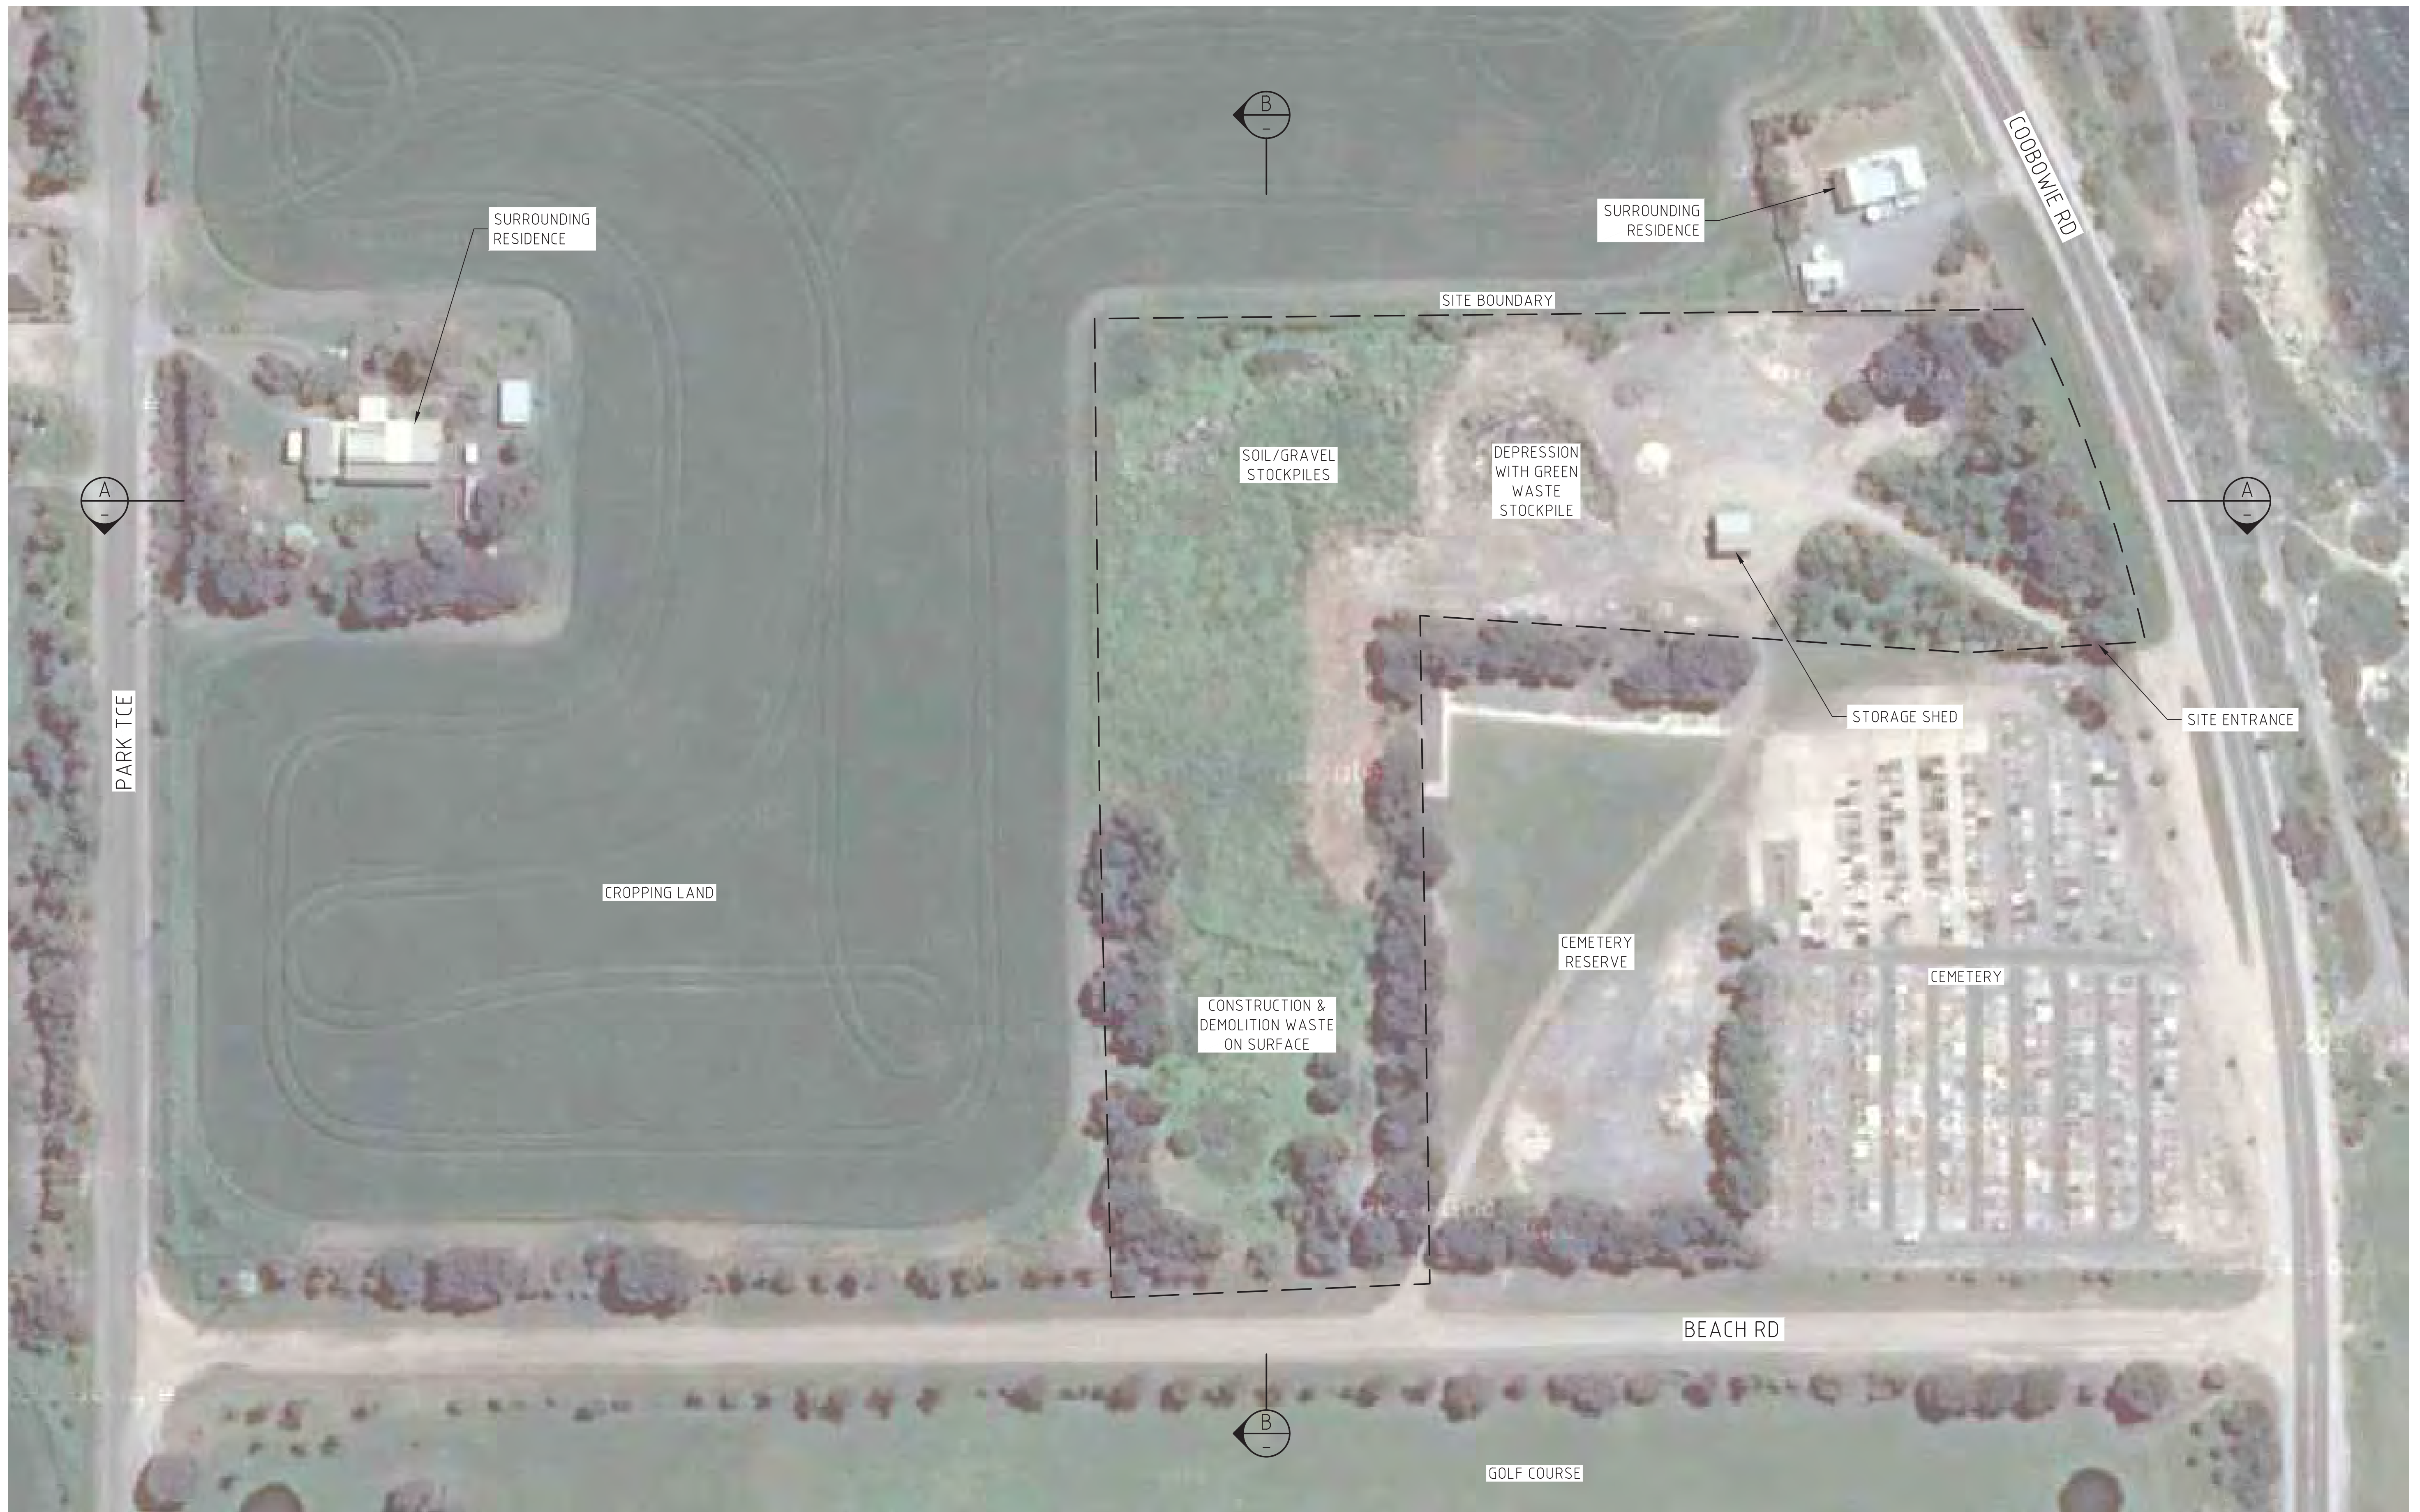
Access Planning
Former Edithburgh Waste Depot
Landfill Gas Risk Assessment
SITE PLAN

The site is located on Coobowie Rd (CR5760/714) and is bounded by Beach Road to the south, the town cemetery to the east and cropping land to the north and west, refer to the site plan on Figure 2.1. The former landfill is located on the northern edge of the Edithburgh township and has a slight gradient towards the east, refer to the topographic map in Appendix A. The golf course on Beach Rd is the immediate receptor between the former landfill and the township. Three residential houses and sheds are located within 200 m of the site. The closest house and shedding to the site is located approximately 5 m from the northern boundary. Respectively the other residents are located 120 m from the eastern boundary and 180 m from the northern boundary.

The site is surrounded (within 500 m of the boundary) by areas of farming land, a golf course and sporting complex, main and secondary roads and residential houses, refer to Figure 2.1. The distances between the nearest sensitive receptors and the edge of site are shown in Table 2–1 below.

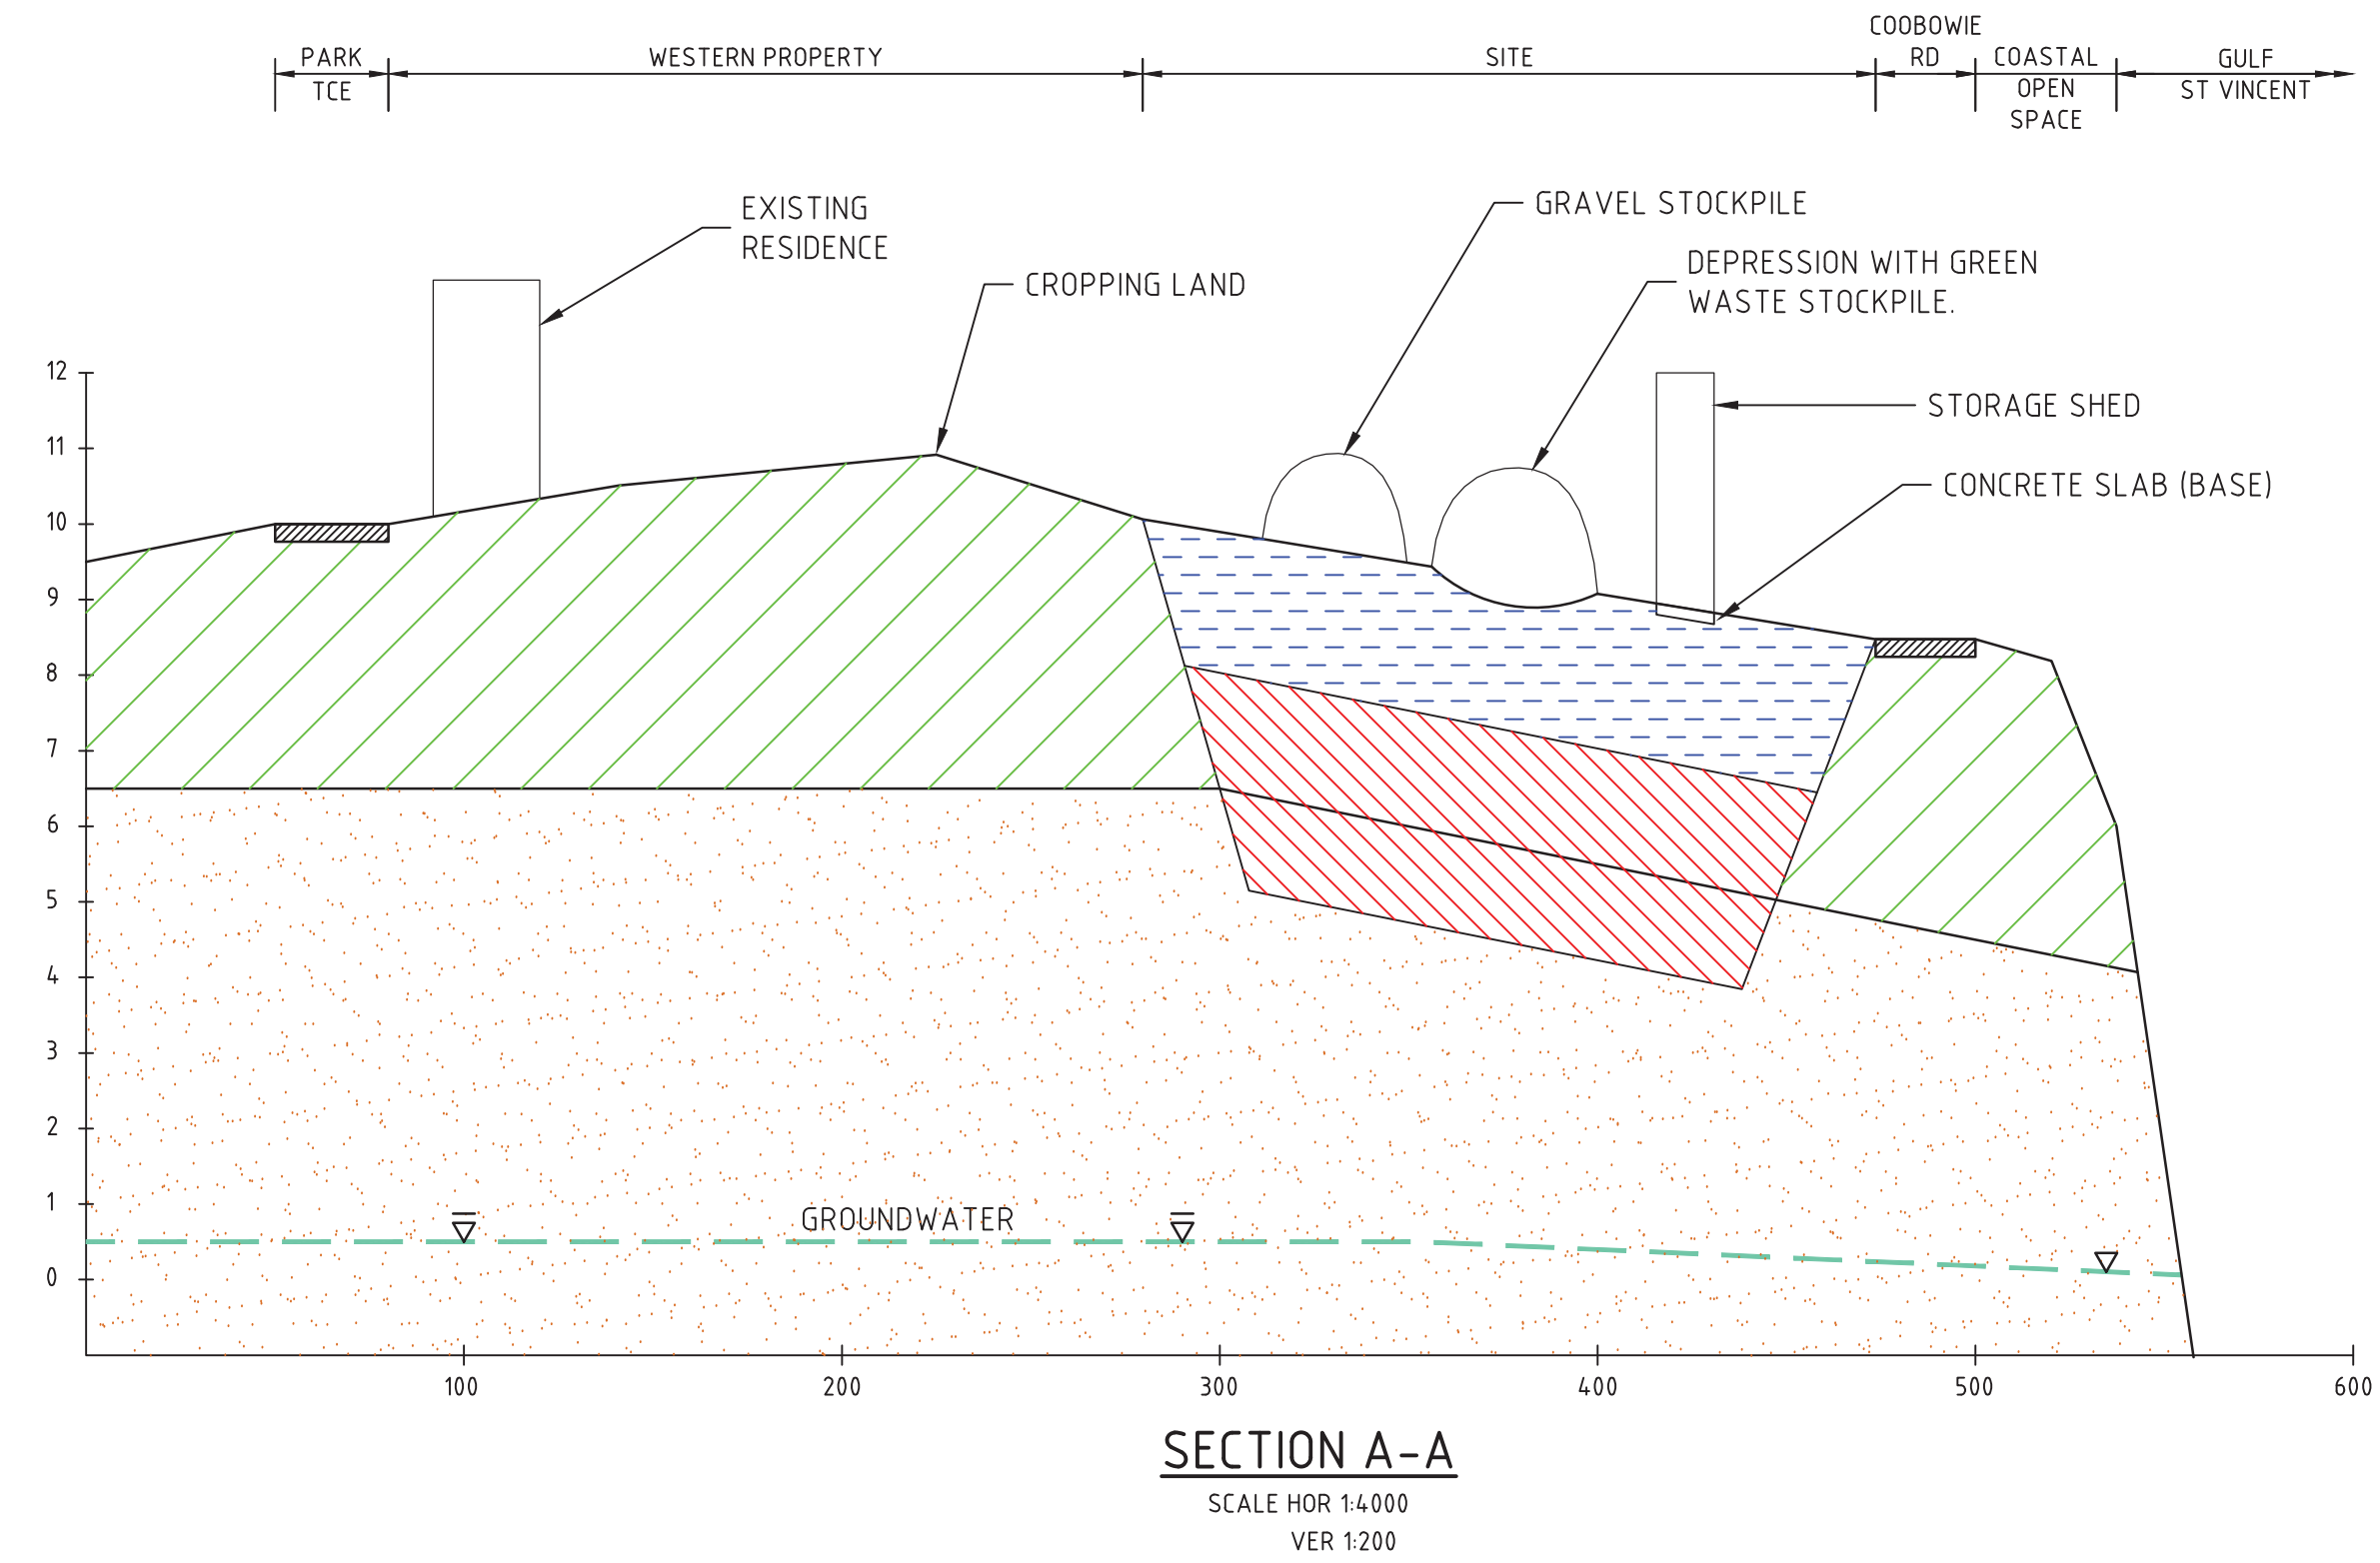
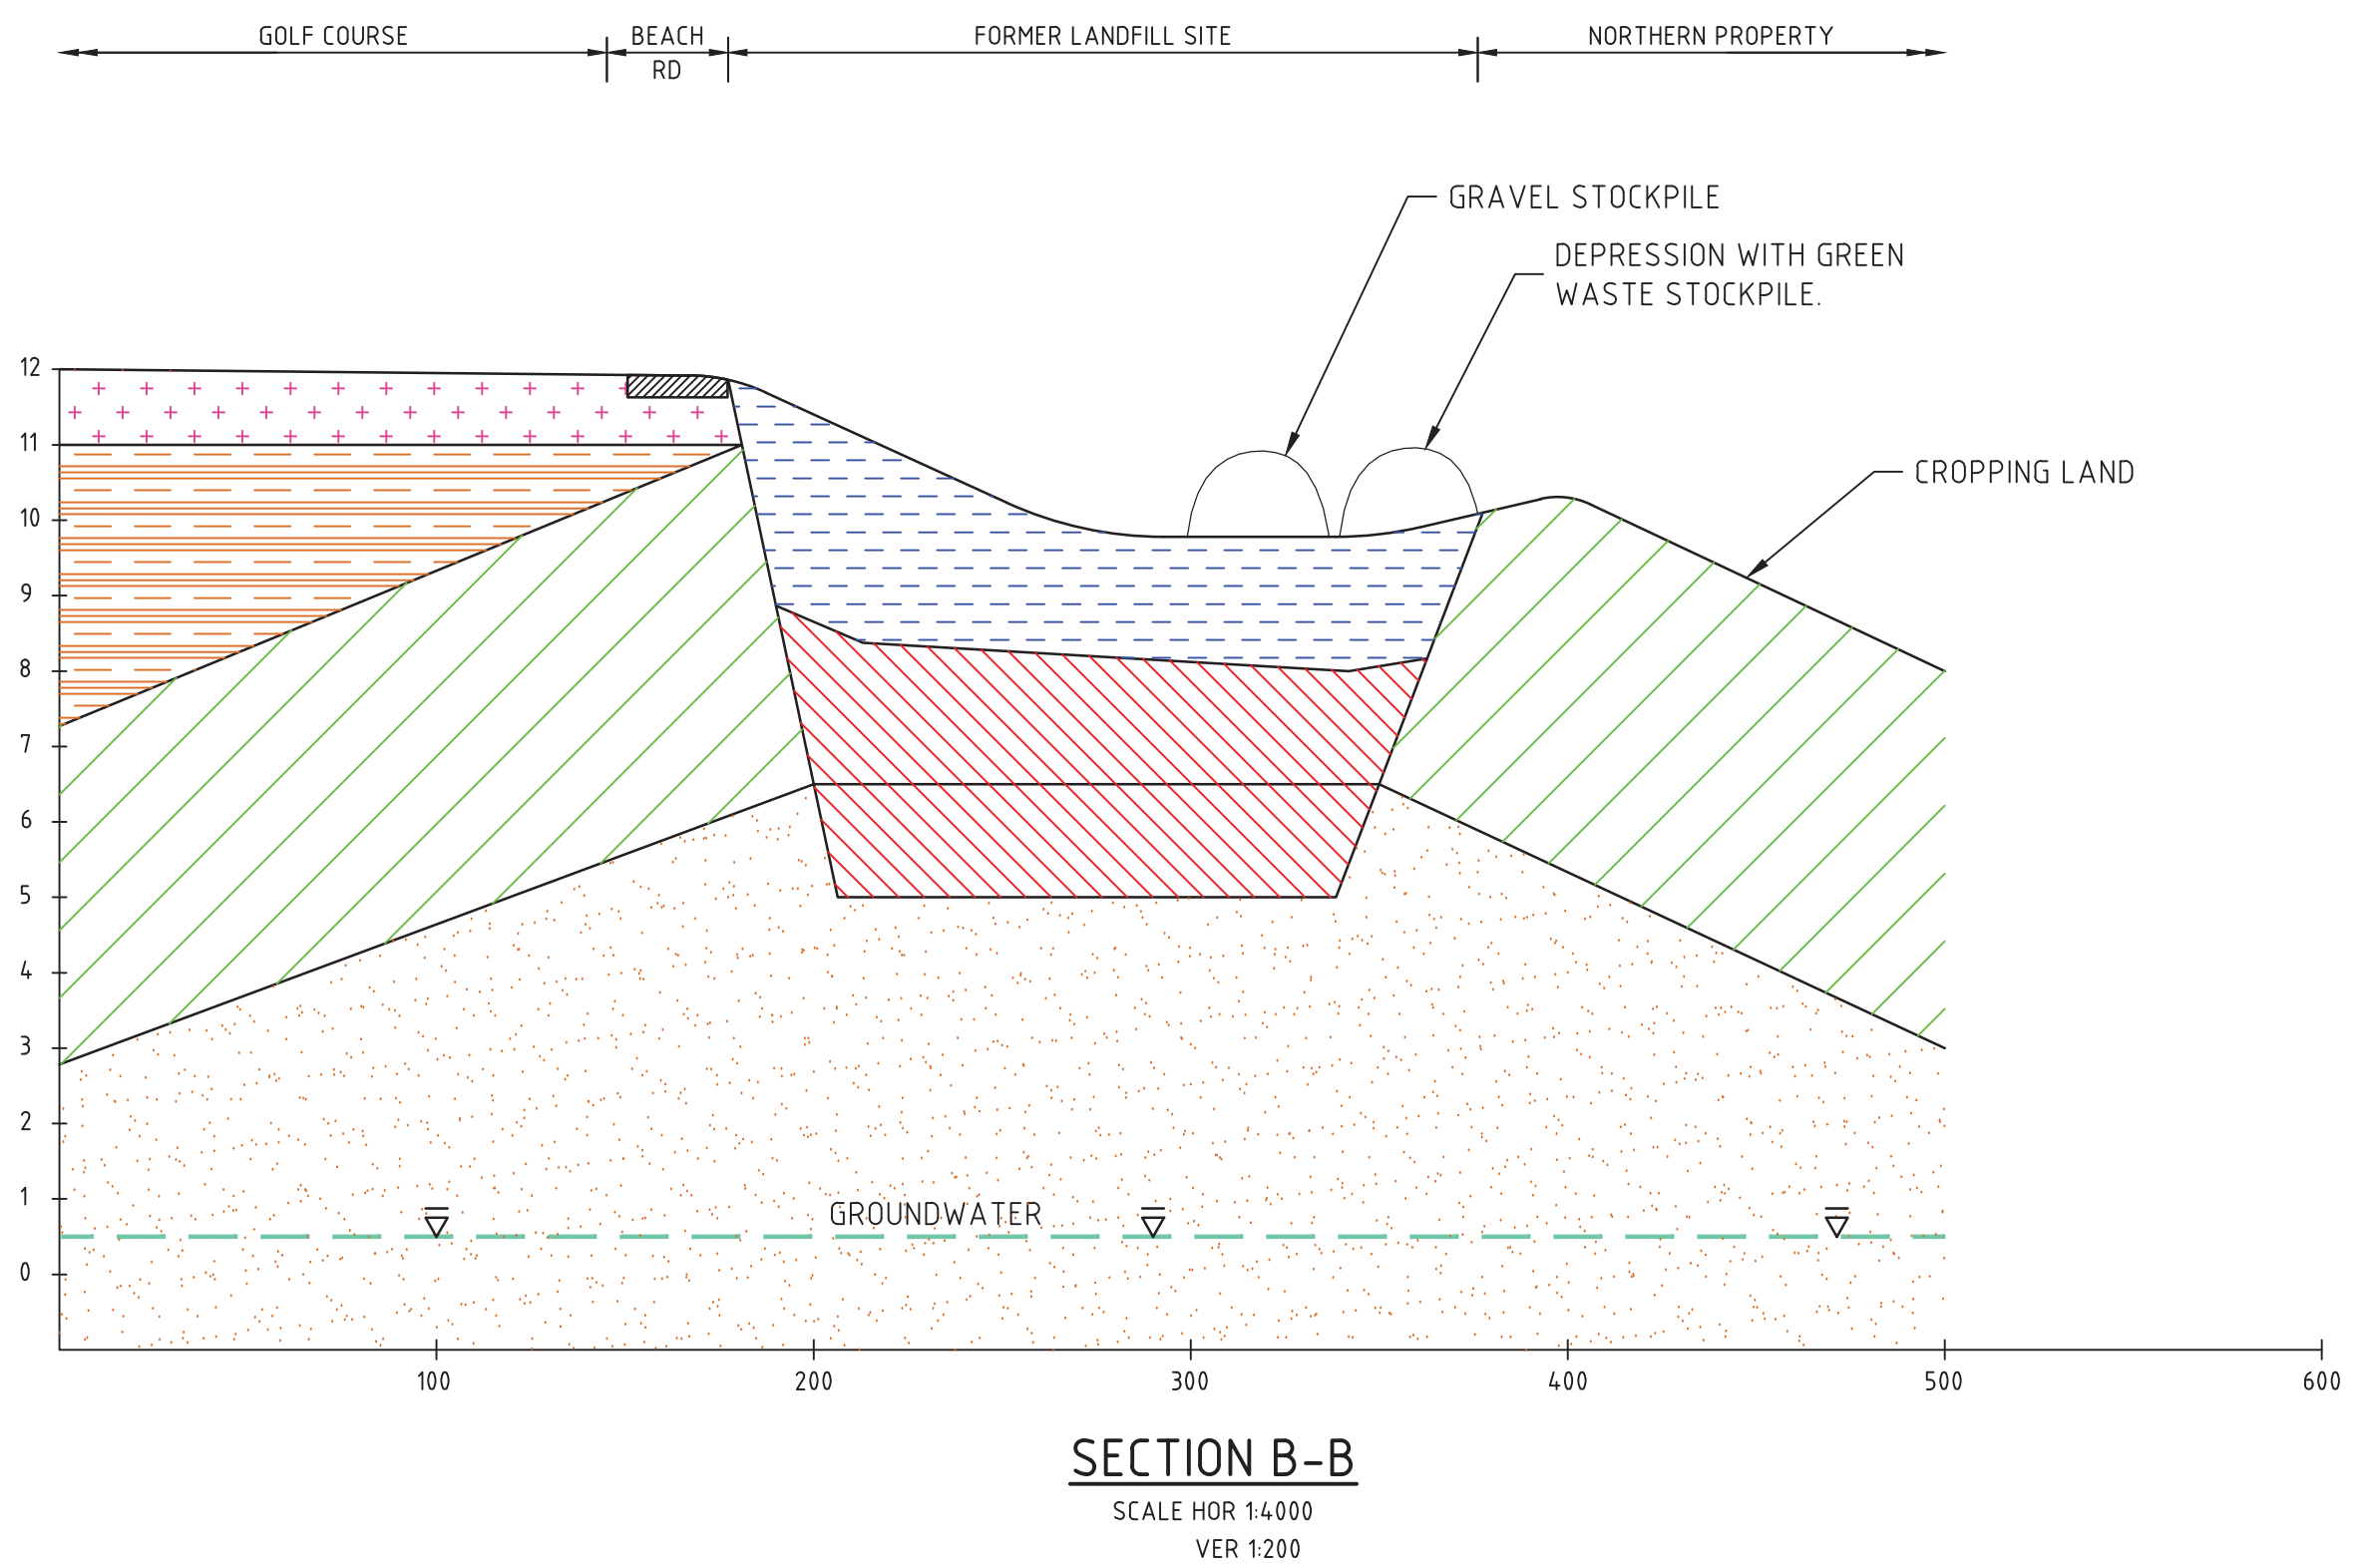
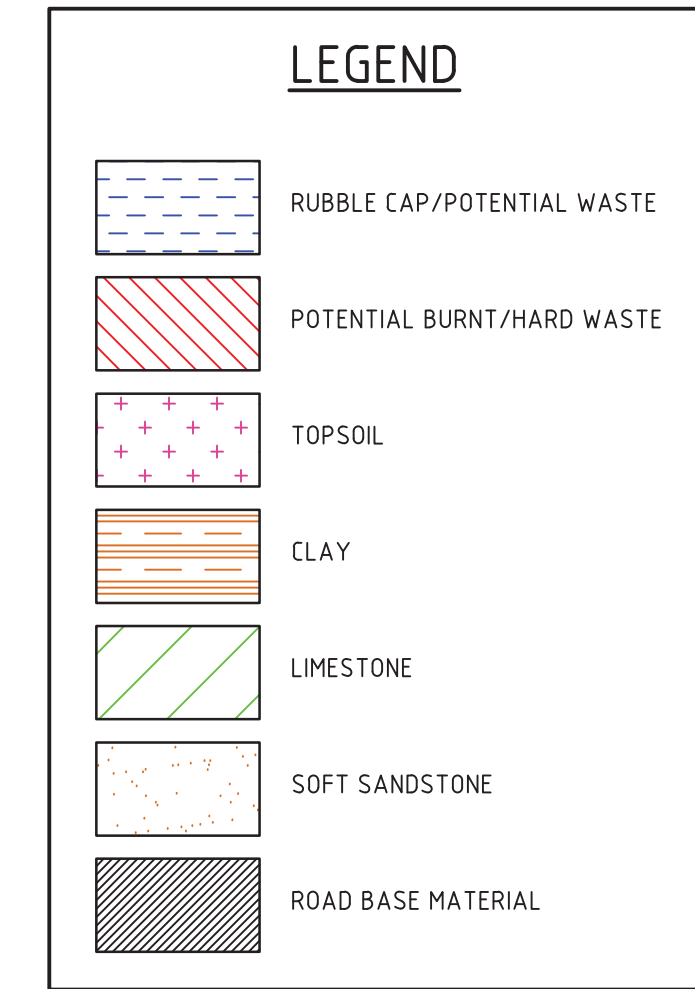
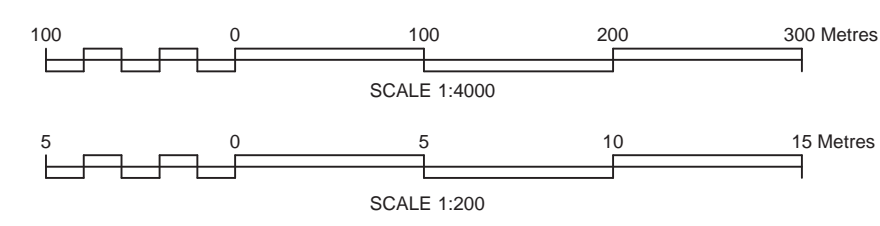
Figure 2.2

The topographical map for Edithburgh indicates that the site generally has a slight grade (1-2%) towards the north east ranging from approximately 11.5 mAHD at the Beach Road Boundary to 8.4 mAHD near Coobowie Rd, refer Appendix A. The topographic map shows that a depression existed in the middle portion of the site in January 1989. The site visit confirmed that a depression still exists in the middle of the site which contains greenwaste and has the potential for ponding of surface water.

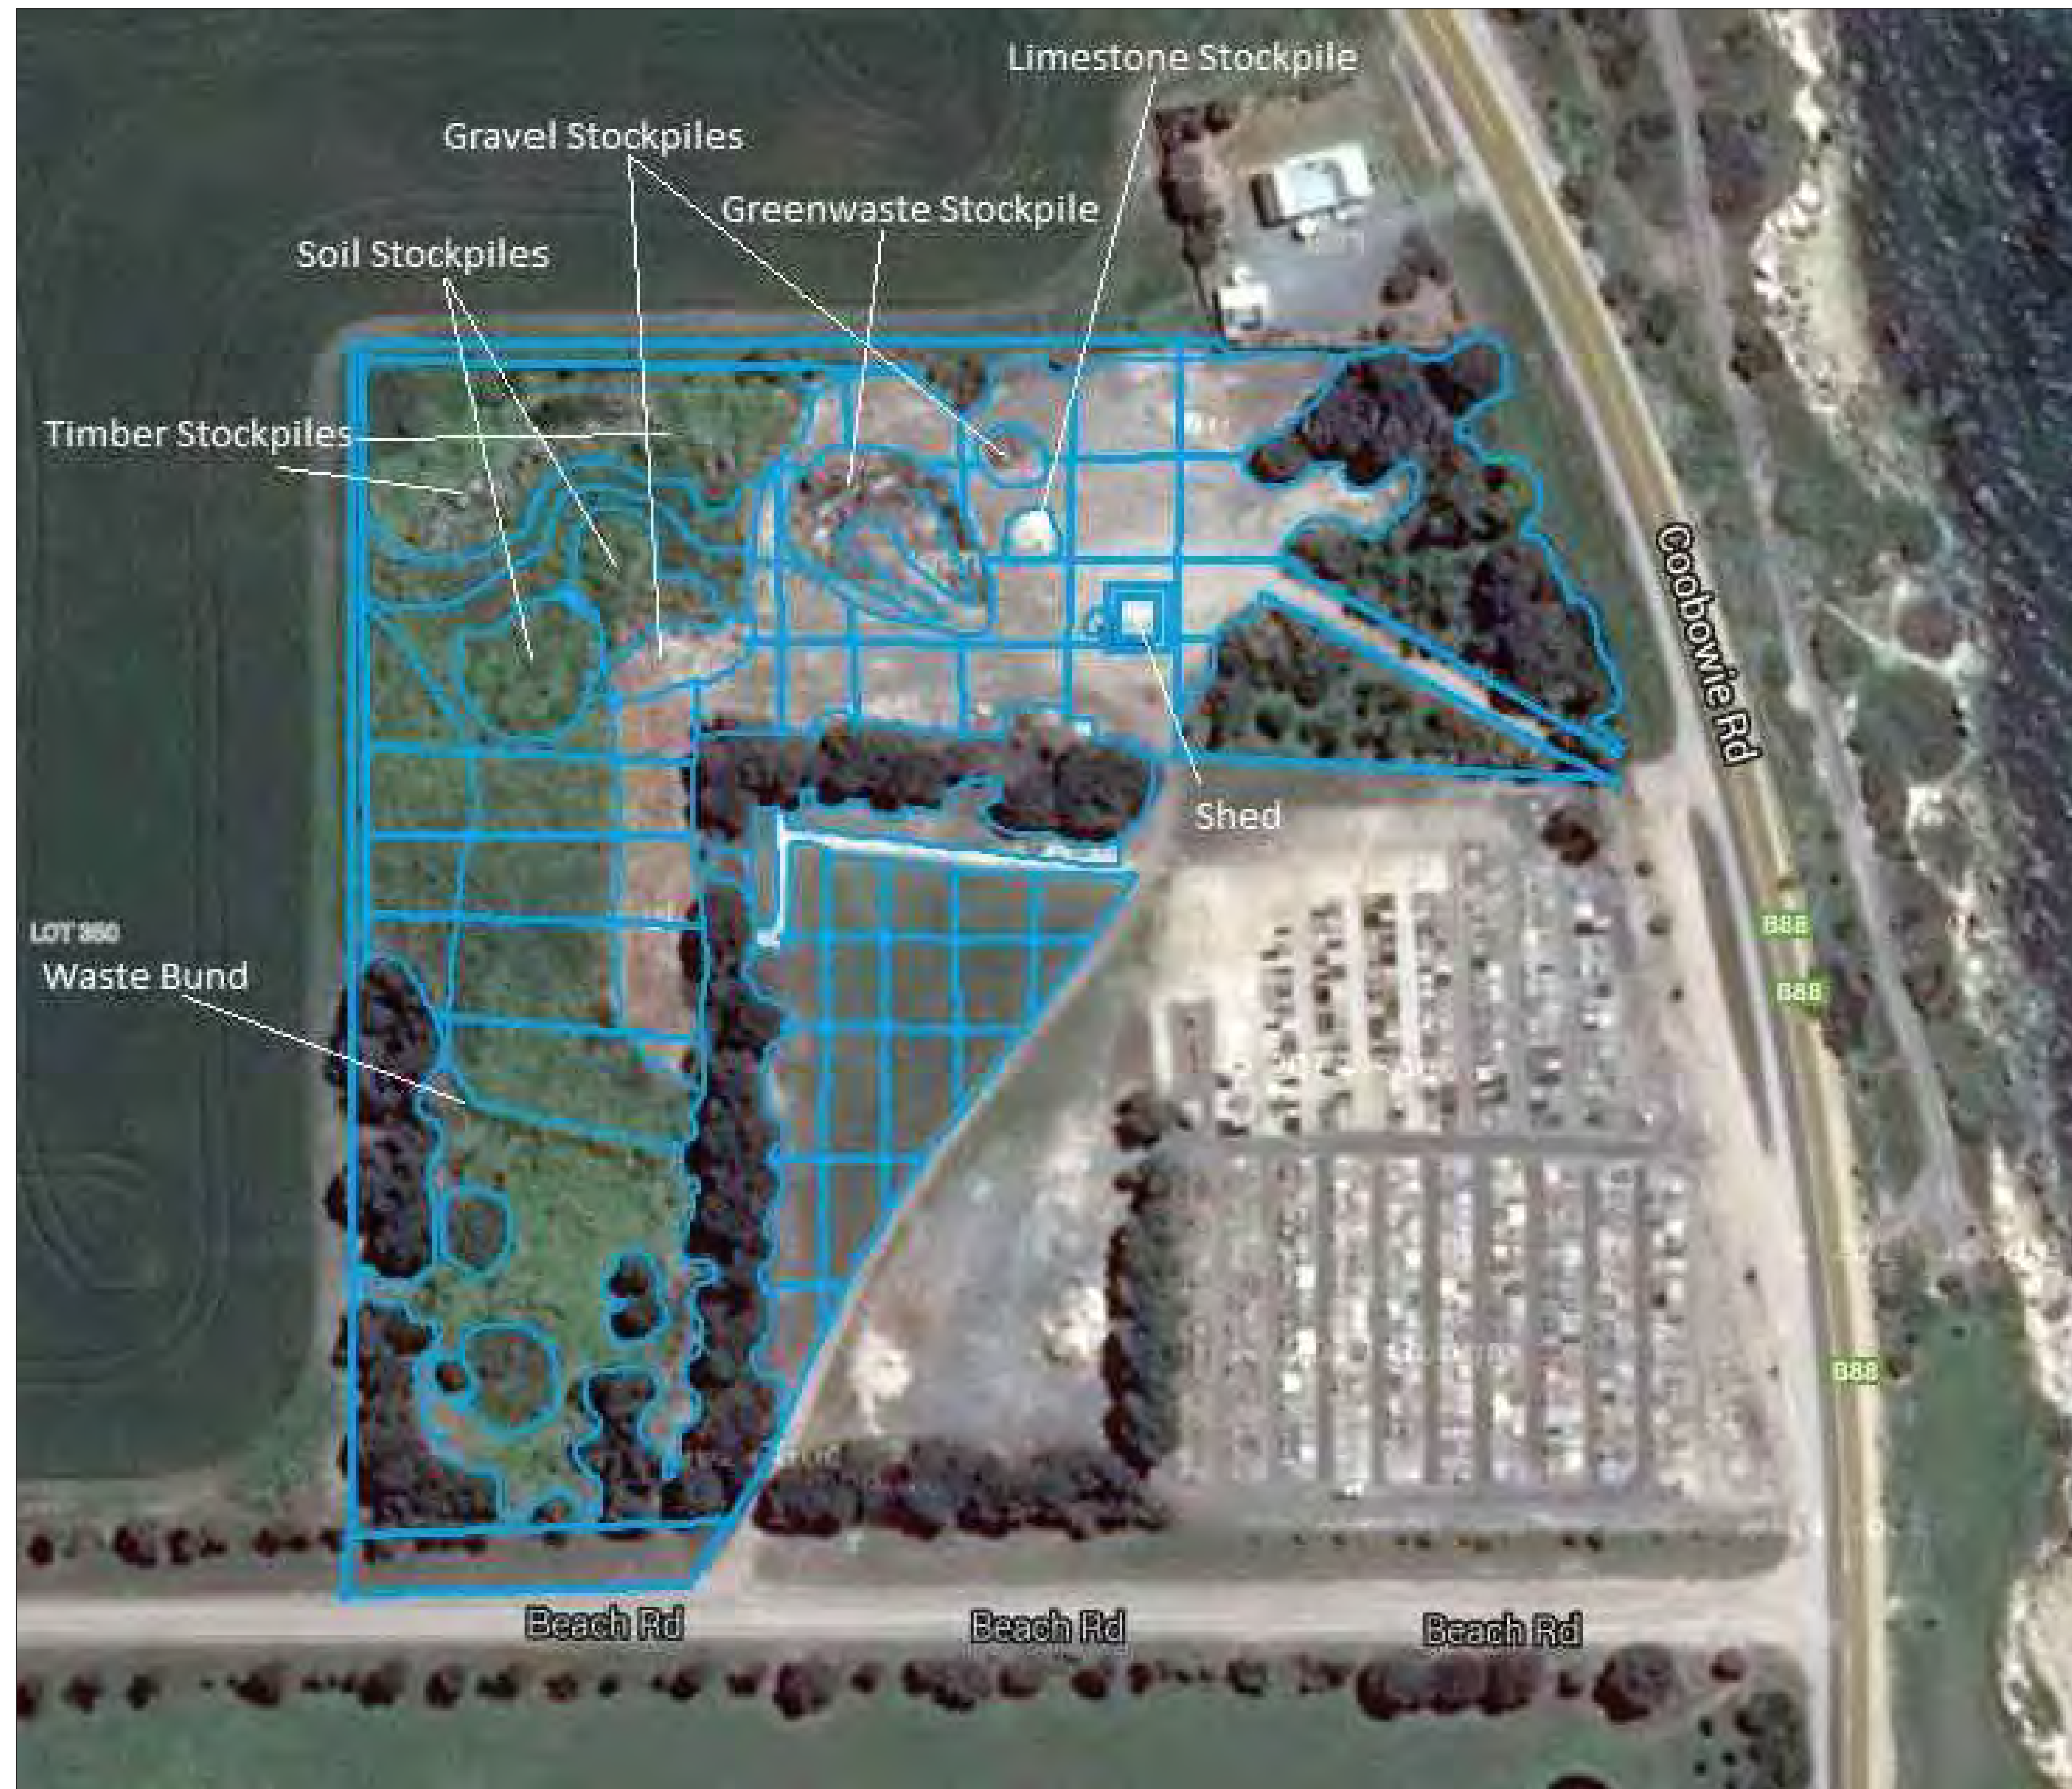
The purpose of the TDL surface survey investigation was to assist in assessing the potential for LFG to be emitted through the capping layer or at the perimeter of the capping layer (i.e. site perimeter). Based on the site visit and anecdotal information the capping layer / final surface is largely comprised of compacted rubble, soil and construction and demolition materials up to a thickness of approximately 2 m. No surface cracking was evident, however some fox or wombat holes were identified. These penetrations into the capping layer occurred at the southern end of site near Beach Road and were monitored for LFG emissions.

The low concentrations of methane detected over the site are considered negligible and are consistent with ambient concentrations. The results of this investigation indicate that the likelihood LFG emissions from the capping material is very low, therefore the risk of emissions and lateral migration to on-site or off-site receptors is also very low. Based on these results and considering the age of waste and historical burning practices, it is estimated that LFG production at the site has peaked and the potential for continued LFG generation is considered to be low.
