YORKE PENINSULA RECREATIONAL BOATING STRATEGY PLAN

DISTRICT COUNCIL OF YORKE PENINSULA

Condition Assessment Survey

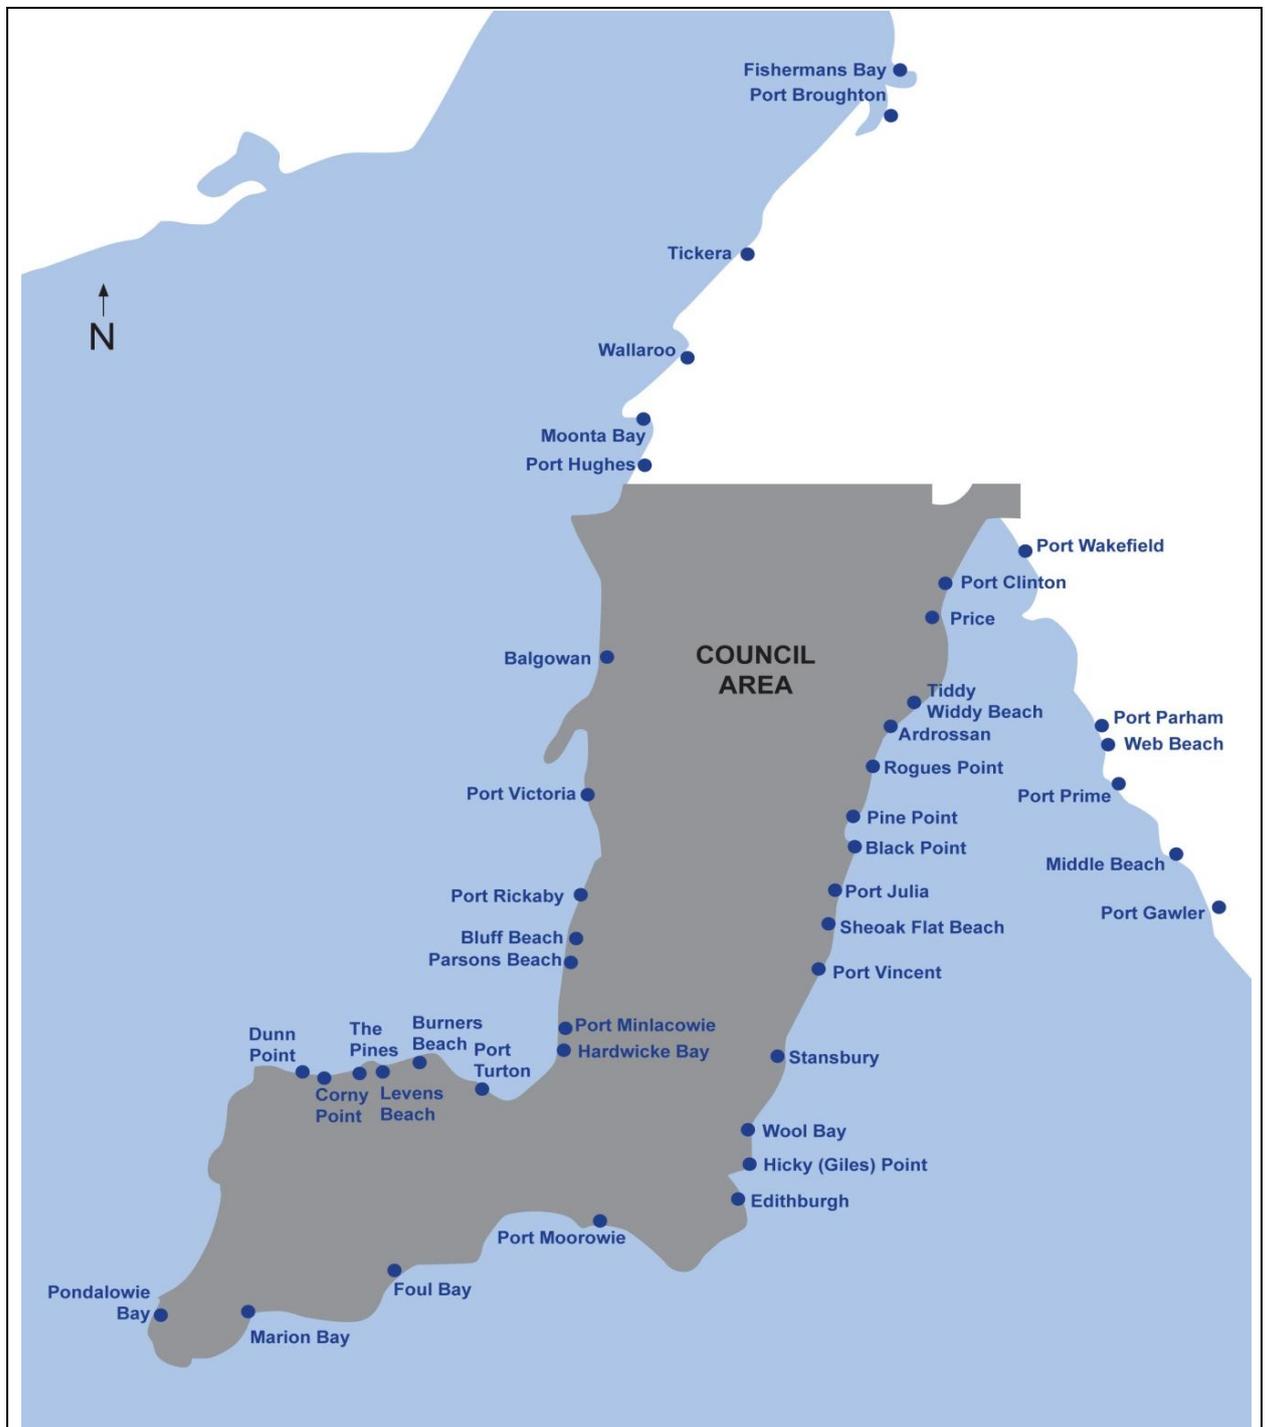
Figure 3.1 Existing recreational boating facilities

The consultants visited all the existing recreational boating facilities on Yorke Peninsula during the period 7 June–10 June 2011 (refer Figure 3.1). These facilities, some thirty-three in all, represent approximately 10% of the total recreational boating facilities in South Australia.

Table 3.1 details the individual facilities and records the classification assigned to each facility. The reference number for each facility is reproduced from the Rust PPK report. Figure 3.1 shows the distribution of these facilities.

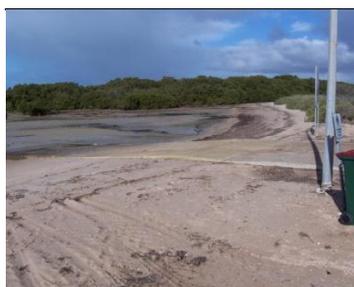
Project Title Yorke Peninsula Recreational Boating Strategy Plan (2011)
 Site Name: **Port Clinton** ID Number (PPK survey): 125
 Classification: 1
 Date of assessment: 8 June 2011

Item	Description	Comment	Rating (1 – 5)
Construction & Condition	<ul style="list-style-type: none"> • Ramp • Trailing arms • Car park • Rigging area • Approach roadway • Berthing pontoons • Jetty/Landings 	<ul style="list-style-type: none"> • Concrete: Poor condition with significant cracking evident • Not provided. Foreshore protection only in good condition • Bitumen spray seal surface in sound condition • Bitumen spray seal surface in sound condition • Sealed surface in good condition • Not provided • Not provided 	<p style="text-align: center;">2</p> <p style="text-align: center;">3</p> <p style="text-align: center;">3</p> <p style="text-align: center;">4</p>
Facilities provided	<ul style="list-style-type: none"> • Number of lanes • Rigging areas • Car parking • Water • Power • Waste collection • Cleaning tables • Shelters • Fuel • Bait shops/fishing supplies 	<ul style="list-style-type: none"> • 1: Beach access only. Toe of ramp covered at high tide • Not delineated • Not delineated • Not provided • Lighting provided at ramp head • Collection bins provided. Signage provided • Not provided • Not provided • Available locally • Available locally

Recommendations	<ul style="list-style-type: none"> • Ramp cracking to be sealed with cement based epoxy mortar • Rigging area to be defined • Car/trailer parking area to be defined

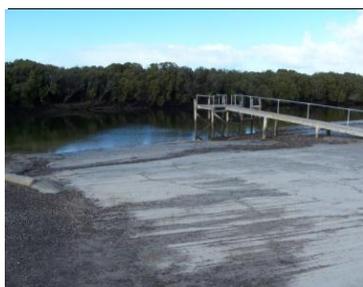
Project Title Yorke Peninsula Recreational Boating Strategy Plan (2011)
 Site Name: ID Number (PPK survey): 124
Price Classification: 1
 Date of assessment: 8 June 2011

Item	Description	Comment	Rating (1 – 5)
Construction & Facilities provided Condition	<ul style="list-style-type: none"> • Ramp • Trailing arms • Car park • Rigging area • Approach roadway • Berthing pontoons • Jetty/Landings 	<ul style="list-style-type: none"> • Concrete: Moderate condition with minor cracking evident at head of ramp • Not provided. Foreshore protection only in good condition • Unsealed surface in sound condition • Unsealed surface in sound condition • Unsealed surface in good condition • Not provided • Timber landing jetty provided. Jetty in moderate condition with warping and splitting of timbers evident 	<p style="text-align: center;">3</p> <p style="text-align: center;">3</p> <p style="text-align: center;">3</p> <p style="text-align: center;">3</p> <p style="text-align: center;">4</p> <p style="text-align: center;">3</p>
	<ul style="list-style-type: none"> • Number of lanes • Rigging areas • Car parking • Water • Power • Waste collection • Cleaning tables • Shelters • Fuel • Bait shops/fishing supplies 	<ul style="list-style-type: none"> • 3: Toe of ramp exposed at lowest tide • Not delineated • Not delineated • Not provided • Lighting provided at ramp head • Not provided • Provided • Provided • Available in township • Available in township

Recommendations	<ul style="list-style-type: none"> • Ramp cracking to be sealed with cement based epoxy mortar • Rigging area to be defined • Staging jetty to be repaired to comply with current OHS standards or consideration to be given for its removal • Car/trailer parking area to be defined • Waste collection bins and signage to be provided

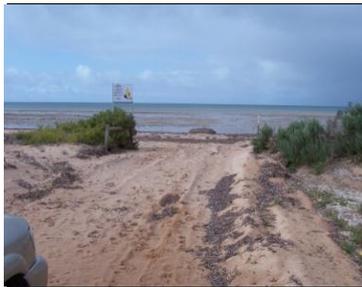
Project Title Yorke Peninsula Recreational Boating Strategy Plan (2011)
 Site Name: **Tiddy Widdy Beach** ID Number (PPK survey): 123
 Classification: 1
 Date of assessment: 8 June 2011

Item	Description	Comment	Rating (1 – 5)
Construction & Condition	<ul style="list-style-type: none"> • Ramp • Trailing arms • Car park • Rigging area • Approach roadway • Berthing pontoons • Jetty/Landings 	<ul style="list-style-type: none"> • Nil: Beach access point only • Not provided. Foreshore dunes in reasonable condition. No evidence of significant or recent erosion • Unsealed graded surface in reasonable condition • Unsealed graded surface in reasonable condition • Unsealed graded surface in poor condition • Not provided • Not provided 	<p style="text-align: center;">1</p> <p style="text-align: center;">2</p> <p style="text-align: center;">2</p> <p style="text-align: center;">1</p>
Facilities provided	<ul style="list-style-type: none"> • Number of lanes • Rigging areas • Car parking • Water • Power • Waste collection • Cleaning tables • Shelters • Fuel • Bait shops/fishing supplies 	<ul style="list-style-type: none"> • 1: Beach access only • Not delineated • Not delineated • Not provided • Lighting not provided • Not provided • Not provided • Minor shelter provided • Available in township (Price/Ardrossan) • Available in township (Price/Ardrossan)

Recommendations	<ul style="list-style-type: none"> • Formal beach access ramp to be provided • Rigging area to be defined • Car/trailer parking area to be defined • Waste collection bins and signage to be provided

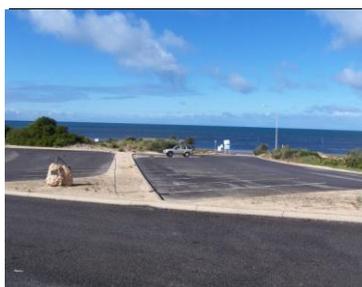
Project Title Yorke Peninsula Recreational Boating Strategy Plan (2011)
 Site Name: **Rogues Point** ID Number (PPK survey): 121
 Classification: 1
 Date of assessment: 8 June 2011

Item	Description	Comment	Rating (1 – 5)
Construction & Condition	<ul style="list-style-type: none"> • Ramp • Trailing arms • Car park • Rigging area • Approach roadway • Berthing pontoons • Jetty/Landings 	<ul style="list-style-type: none"> • Nil: Bitumen sealed beach access point only in good condition • Not provided. Foreshore dunes in reasonable condition. No evidence of erosion • Bitumen sealed car/trailer and car only parking in good condition • Bitumen sealed rigging area provided in good condition • Bitumen sealed roadway in good condition • Not provided • Not provided 	<p style="text-align: center;">4</p> <p style="text-align: center;">3</p> <p style="text-align: center;">4</p> <p style="text-align: center;">4</p> <p style="text-align: center;">4</p>
Facilities provided	<ul style="list-style-type: none"> • Number of lanes • Rigging areas • Car parking • Water • Power • Waste collection • Cleaning tables • Shelters • Fuel • Bait shops/fishing supplies 	<ul style="list-style-type: none"> • 1: Beach access only • Well defined and delineated • Well defined and delineated • Not provided • Lighting provided at head of ramp • Not provided • Not provided • Not provided • Available in township (Ardrossan) • Available in township (Ardrossan)

Recommendations	<ul style="list-style-type: none"> • Waste collection bins and signage to be provided

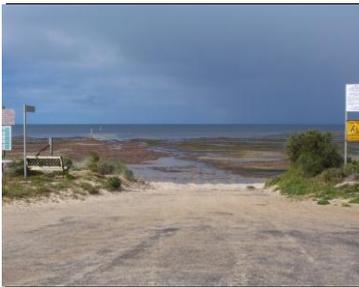
Project Title Yorke Peninsula Recreational Boating Strategy Plan (2011)
 Site Name: **Pine Point** ID Number (PPK survey): 120
 Date of assessment: 8 June 2011 Classification: 1

Item	Description	Comment	Rating (1 – 5)
Construction & Condition	<ul style="list-style-type: none"> • Ramp • Trailing arms • Car park • Rigging area • Approach roadway • Berthing pontoons • Jetty/Landings 	<ul style="list-style-type: none"> • Nil: Bitumen sealed beach access point only in sound condition • Not provided. Foreshore dunes in reasonable condition. No evidence of erosion • Newly laid bitumen sealed surface in good condition. • Undefined • Unsealed graded surface in sound condition • Not provided • Not provided 	<p style="text-align: center;">3</p> <p style="text-align: center;">4</p> <p style="text-align: center;">3</p> <p style="text-align: center;">3</p>
Facilities provided	<ul style="list-style-type: none"> • Number of lanes • Rigging areas • Car parking • Water • Power • Waste collection • Recycling collection • Cleaning tables • Shelters • Fuel • Bait shops/fishing supplies 	<ul style="list-style-type: none"> • 1: Beach access only • Not delineated • Delineated parking for 9 car/trailer combinations • Not provided • Not provided • Not provided • Recycling collection point provided with signage • Not provided • Beach shelter adjacent • Available in township • Available in township

Recommendations	<ul style="list-style-type: none"> • Waste collection bins and signage to be provided • Rigging area to be delineated

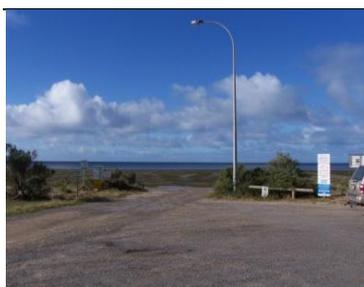
Project Title Yorke Peninsula Recreational Boating Strategy Plan (2011)
 Site Name: **Sheoak Flat** ID Number (PPK survey): Not identified
 Classification: 1
 Date of assessment: 8 June 2011

Item	Description	Comment	Rating (1 – 5)
Construction & Condition	<ul style="list-style-type: none"> • Ramp • Trailing arms • Car/trailer park • Rigging area • Approach roadway • Berthing pontoons • Jetty/Landings 	<ul style="list-style-type: none"> • Nil: Beach access point only. Sealed surface in reasonable condition • Not provided. Foreshore dunes in reasonable condition. No evidence of erosion • Unsealed graded surface in reasonable condition • Unsealed graded surface in reasonable condition • Unsealed graded surface in reasonable condition • Not provided • Not provided 	<p style="text-align: center;">2</p> <p style="text-align: center;">3</p> <p style="text-align: center;">2</p> <p style="text-align: center;">2</p> <p style="text-align: center;">2</p>
Facilities provided	<ul style="list-style-type: none"> • Number of lanes • Rigging areas • Car parking • Water • Power • Waste collection • Cleaning tables • Shelters • Fuel • Bait shops/fishing supplies 	<ul style="list-style-type: none"> • Single lane beach access only • Not delineated • Not delineated • Not provided • Lighting provided at head of ramp • Not provided • Not provided • Not provided • Available in adjacent township (Port Vincent) • Available in adjacent township (Port Vincent)

Recommendations	<ul style="list-style-type: none"> • Rigging area to be delineated • Car/trailer area to be graded and sealed • Car/trailer parking bays to be defined by line marking • Waste collection and signage to be provided

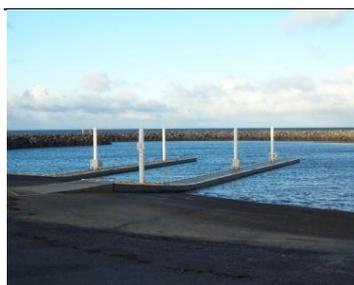
Project Title Yorke Peninsula Recreational Boating Strategy Plan (2011)
 Site Name: **Edithburgh** ID Number (PPK survey): 145
 Date of assessment: 8 June 2011 Classification: 2/3

Item	Description	Comment	Rating (1 – 5)
Construction & Condition	• Ramp	• Multi-lane concrete ramp provided. Ramp in sound condition but longitudinal cracking evidenced. No evidence of displacement	4

• Jetty/Landings	• Not provided	
Facilities provided	<ul style="list-style-type: none"> • Number of lanes • Rigging areas • Car parking • Water • Power • Waste collection • Cleaning tables • Shelters • Fuel • Bait shops/fishing supplies 	<ul style="list-style-type: none"> • 5; 4 serviced by pontoons • Clearly delineated • Delineated by pavement markings • Provided • Lighting provided • Provided • Not provided • Provided • Available in township • Available in township 	
Recommendations	<ul style="list-style-type: none"> • Cracking to ramp to be repaired with cement based epoxy mortar • Minor repairs to access roadway to be completed

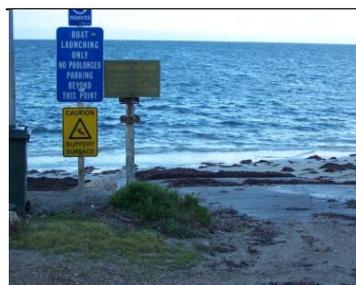
Site Name: **Port Moorowie** ID Number (PPK survey): 143

• Berthing pontoons • Jetty/Landings	• Not provided • Not provided	
Facilities provided	<ul style="list-style-type: none"> • Number of lanes • Rigging areas • Car parking • Water • Power • Waste collection • Cleaning tables • Shelters • Fuel • Bait shops/fishing supplies 	<ul style="list-style-type: none"> • Single lane. Toe dries at low tide. Suitable for beach access only • Not delineated • Not delineated • Not provided • Lighting provided at head of ramp • Provided at head of ramp • Not provided • Not provided • Available in nearby township (Edithburgh) • Available in nearby township (Edithburgh) 	
Recommendations	<ul style="list-style-type: none"> • Cracking to ramp to be repaired with cement based epoxy mortar • Minor repairs to access roadway to be undertaken • Manoeuvring area at head of ramp to be regraded • Rigging area to be formalised • Waste bins to be provided to car/trailer park • Consideration to be given to public lighting of car/trailer parking area

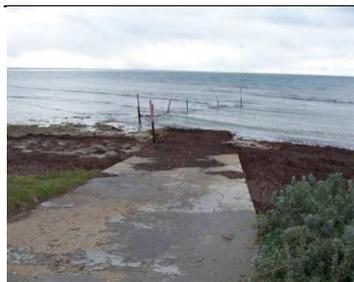
Site Name: **Foul Bay** ID Number (PPK survey): 141

• Rigging area	• Undefined	1
	• Approach roadway	• Unsealed graded surface in poor condition	2
	• Berthing pontoons	• Not provided	
	• Jetty/Landings	• Not provided	
Facilities provided	<ul style="list-style-type: none"> • Number of lanes • Rigging areas • Car parking • Water • Power • Waste collection • Cleaning tables • Shelters • Fuel • Bait shops/fishing supplies 	<ul style="list-style-type: none"> • Single lane. Toe dries at low tide. Beach access only • Not delineated • Not delineated • Not provided • Lighting not provided • Not provided • Not provided • Not provided • Available in adjacent township (Edithburgh) • Available in adjacent (Edithburgh) 	
Recommendations	<ul style="list-style-type: none"> • Cracking to ramp to be repaired with cement based epoxy mortar • Side wall protection to be provided • Repairs to access roadway to be undertaken • Rigging area to be formalised • Waste bins to be provided to car/trailer park • Lighting at head of ramp to be provided

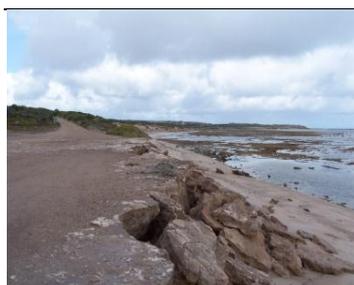
Item	Description	Comment	Rating (1 – 5)
Construction & Condition	<ul style="list-style-type: none"> • Ramp • Trailing arms • Car park • Rigging area • Approach roadway • Berthing pontoons • Jetty/Landings 	<ul style="list-style-type: none"> • Nil: Beach access point only • Not provided. • Unsealed graded surface in reasonable condition • Not provided • Unsealed graded surface in poor condition • Not provided • Not provided 	<p>1</p> <p>1</p> <p>1</p> <p>1</p> <p>1</p>
Facilities provided	<ul style="list-style-type: none"> • Number of lanes • Rigging areas • Car parking • Water • Power • Waste collection • Cleaning tables • Shelters • Fuel • Bait shops/fishing supplies 	<ul style="list-style-type: none"> • Beach access only • Not delineated • Not delineated • Not provided • Not available • Not available 	
Recommendations	<p>The use of Gleeson's landing as a launching site has ceased with the beach access point not blocked off. The area is now in use as a camping ground offering only basic facilities.</p> <p>It is therefore recommended that this facility be removed from the register of launching sites available on Yorke Peninsula.</p>

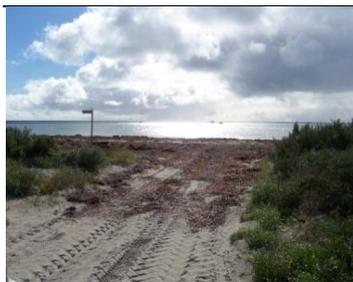
Project Title Yorke Peninsula Recreational Boating Strategy Plan (2011)
 Site Name: **Corny Point** ID Number (PPK survey): 137
 Classification: 1
 Date of assessment: 9 June 2011

Item	Description	Comment	Rating (1 – 5)
Construction & Condition	<ul style="list-style-type: none"> • Ramp • Trailing arms • Car/trailer park • Rigging area • Approach roadway • Berthing pontoons • Jetty/Landings 	<ul style="list-style-type: none"> • Nil: Beach access point only • Not provided. Foreshore dunes in reasonable condition. No evidence of erosion. Evidence however of loss of dunes through human practices • Not provided • Not provided • Unsealed surface in poor condition • Not provided • Not provided 	<p style="text-align: center;">1</p>
Facilities provided	<ul style="list-style-type: none"> • Number of lanes • Rigging areas • Car parking • Water • Power • Waste collection • Cleaning tables • Shelters • Fuel • Bait shops/fishing supplies 	<ul style="list-style-type: none"> • 1: Beach access only • Not provided • Available in township • Available in township 	
Recommendations	<p>The present facilities comprise several informal access tracks over the coastal dunes. No permanent facilities are provided. Human behaviour is causing loss of dunes through uncontrolled access.</p> <ul style="list-style-type: none"> • Consideration to be given to the provision of a dedicated launching ramp with appropriate support infrastructure • Existing beach access points to be regulated to prevent loss of foreshore dunes.

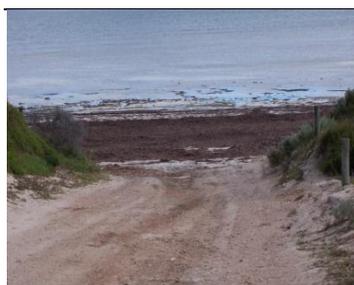
Project Title Yorke Peninsula Recreational Boating Strategy Plan (2011)
 Site Name: **Parsons Beach** ID Number (PPK survey): 128
 Classification: 1
 Date of assessment: 9 June 2011

• Jetty/Landings	• Not provided	
Facilities provided	<ul style="list-style-type: none"> • Number of lanes • Rigging areas • Car parking • Water • Power • Waste collection • Cleaning tables • Shelters • Fuel • Bait shops/fishing supplies 	<ul style="list-style-type: none"> • Single lane: Beach access only • Not provided • Available in nearby township (Minlaton) • Available in nearby township (Minlaton) 	
Recommendations	<ul style="list-style-type: none"> • Ramp to be regraded and bitumen sealed • Car/trailer parking area to be provided • Rigging area to be provided • Waste collection bins to be provided
