Re: Beach management adjacent the Black Point boat ramp

Black Point
Boat Ramp Survey 16/10/2017

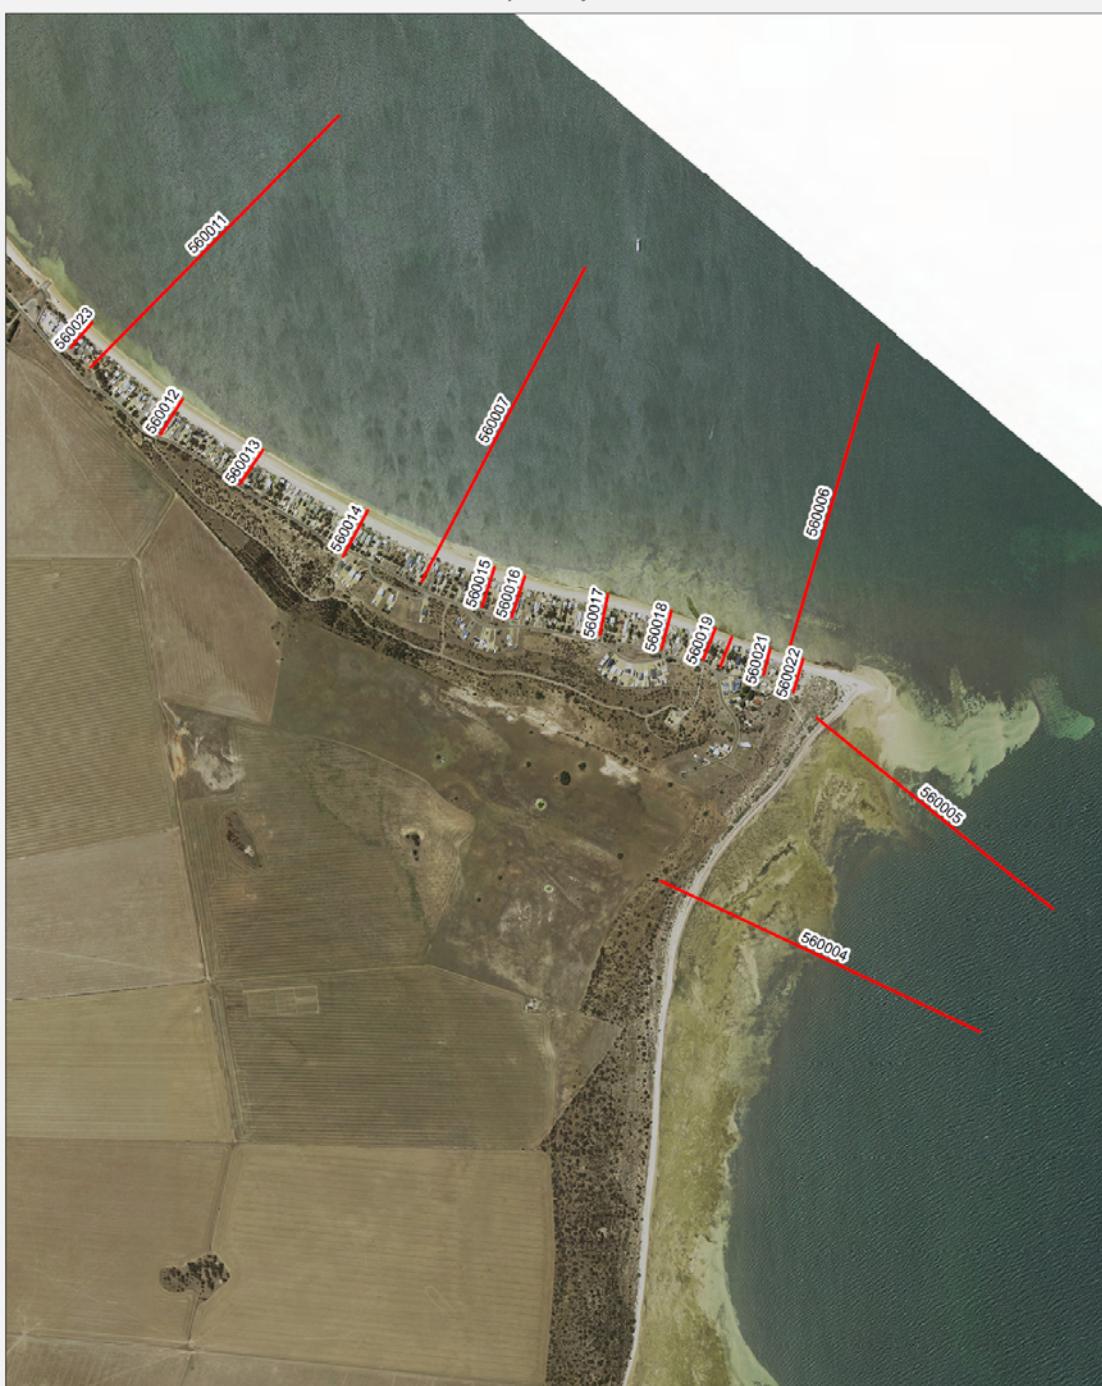
Figure 1: Beach profile locations at Black Point

DEWNR established several beach profiles at Black Point, some towards the south-east were first surveyed in 1975. The location and reference numbers of these profiles can be seen in Figure 1. Several profiles were resurveyed on 16 October 2017 and the collated data from these profiles (from north-west to south-east: 560023, 560011, 560007, 560006, 560005) can be seen in Figures 2 to 6. In addition, a high-resolution survey of the area surrounding the boat ramp was also surveyed in October 2017 (terrestrial; and hydrographic) to establish a baseline digital elevation model at the site (Figure 7).
